**Chemung County Stormwater
Construction Inspection
Erosion and Sediment Control**

Project Name Barrington West Lot 54	Date 6-28-2022
Location Royal Crest Horseheads, NY	Permit # NYR11F212
Weather Conditions sunny warm	Entry Time: 10:26 am
On-Site Representative Present: Roz Steadman	Exit Time: 10:50 am

PROJECT: Barrington West Lot 54
Town of Horseheads
Municipal Inspection
June 28, 2022

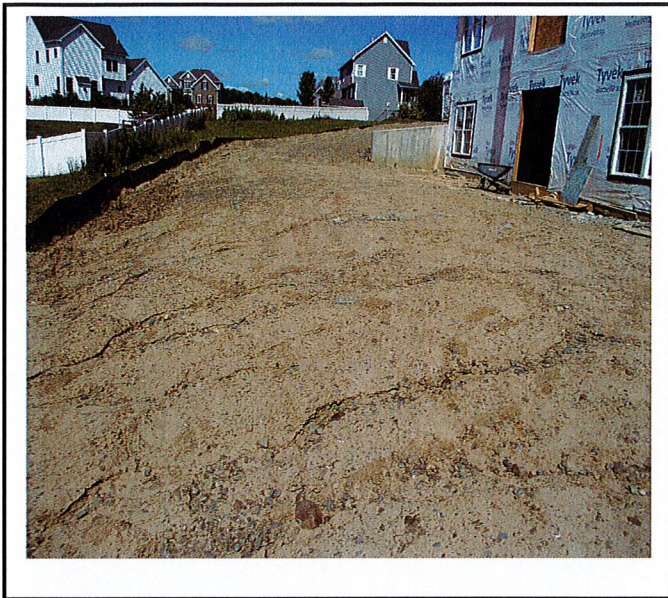
Erosion occurring at rear of property.

-Erosion occurring around the entire property because nothing is stabilized. Silt fenced are capturing the sediment. See not above on when this will be corrected.

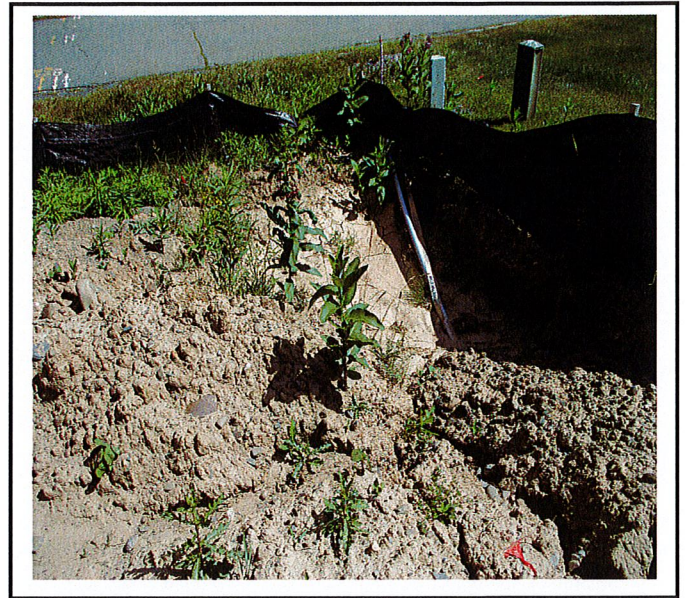
Silt fence not toed in where electric line needs to be buried.

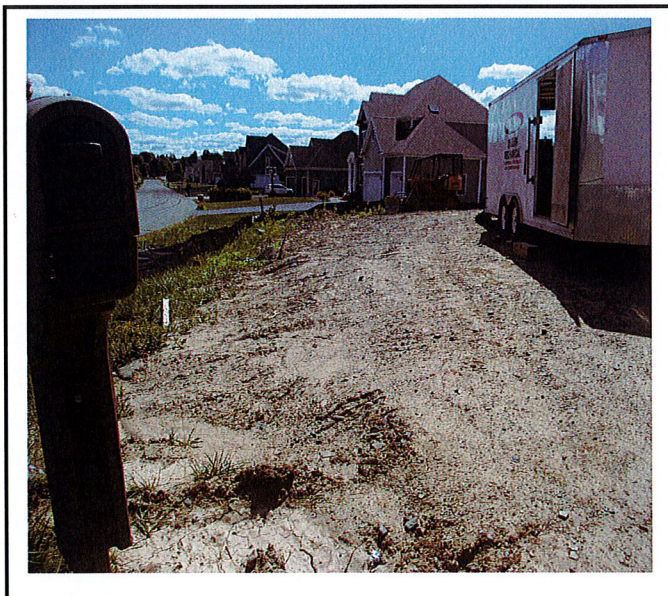
Bare compacted soil is eroding due to lack of stabilization.

-Spoke with developer on site. Waiting for Will Wood to come back and finish electric and plumbing lines into home. When he does that he will rough grade the site and they will get it stabilized. Roof gutters will be in by then too. Majority of roofs will flow out to front.
