**Chemung County Stormwater  
Construction Inspection  
Erosion and Sediment Control**

| <b>Project Name</b> Hickory Grove Road Solar Project | <b>Date</b> 7-15-2020 |
| <b>Location</b> Hickory Grove Road Horseheads, NY | <b>Permit #</b> NYR11F809 |

| | Municipal Inspection |

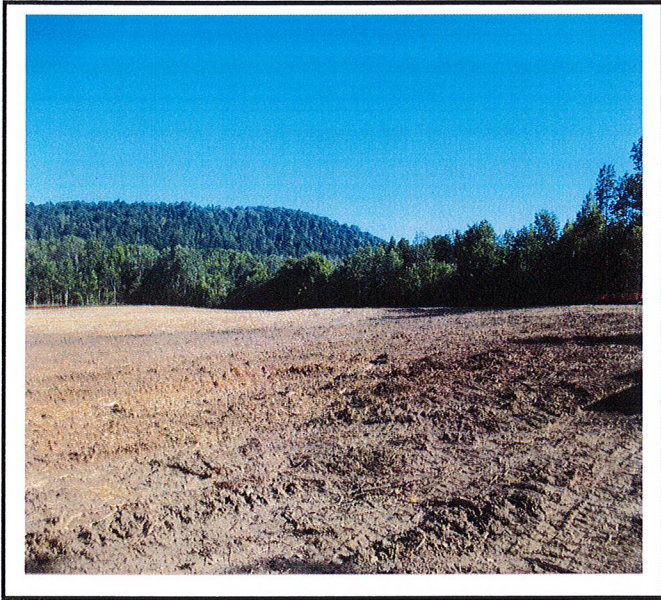
Over 5 acres disturbed without authorization.

| -The project has disturbed over 5 acres without authorization. Site must get under the 5 acres or get authorization. Contractor is actively working to get the soil stabilized and get under the 5 acre threshold. | | | |

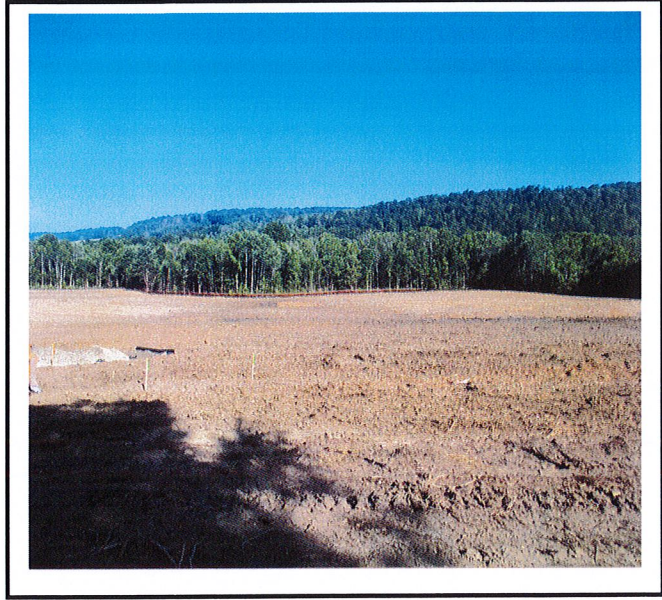
Over 5 acres disturbed without authorization.

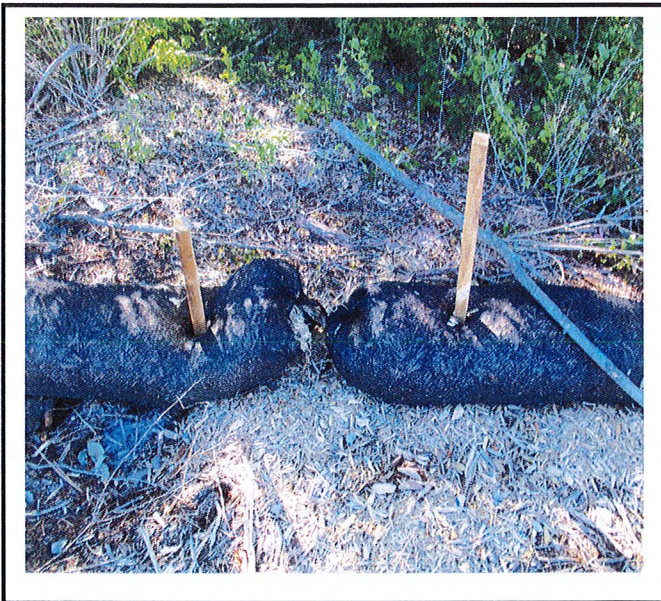
| -The filter sock that runs parallel to Hickory Grove road to the SW end of property is not overlapped correctly. | | | |

No overlap on the compost filter sock.
