**Chemung County Stormwater
Construction Inspection
Erosion and Sediment Control**

Project Name Glad Tidings Building Exp	Date 1-9-19
Location 116 Breesport Rd Horseheads, NY	Permit # NYR11A108
Weather Conditions Overcast cold	Entry Time: 11:58 am
On-Site Representative Present: None	Exit Time: 12:14 pm

PROJECT: Glad Tidings Church
Town of Horsehead
Municipal Construction Inspection
January 9, 2019

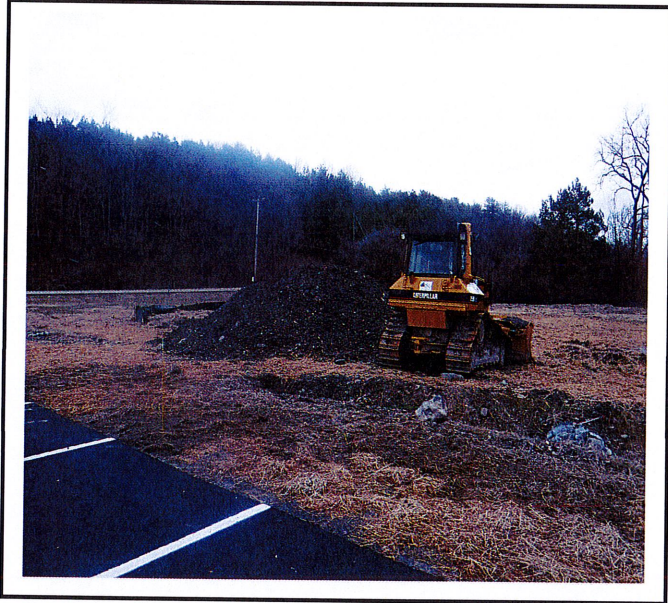
Equipment and soil stockpile still on site.

- Open exposed topsoil pile is still on site.
- Mortar pile is on the ground near infiltration basin and needs to be picked up.
- Final grading at the east side of the basin needs to be cleaned up in the spring. It needs to be re-graded.
- Fuel tank needs to be relocated. Having it directly next to and tributary to the infiltration basin is a pollution concern.

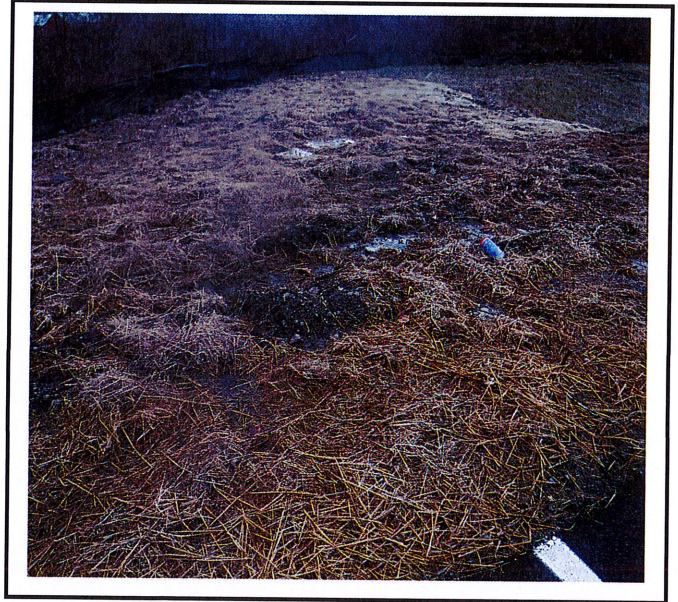
Areas around stormwater basin will need to be re-graded to the original design.

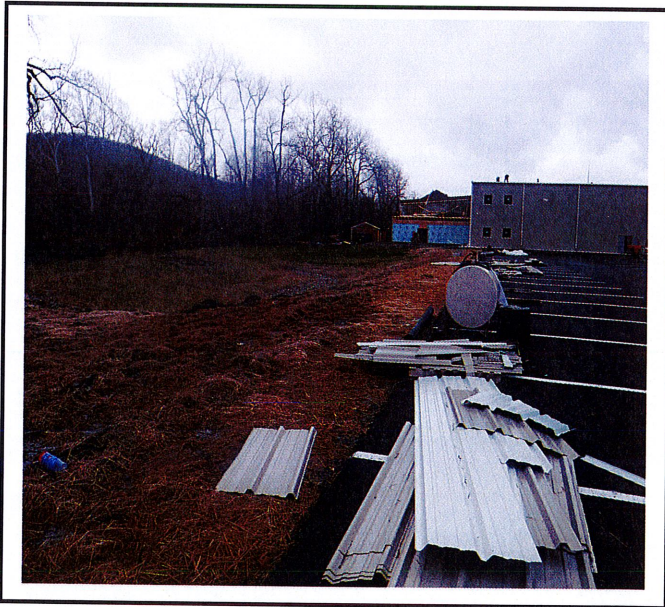
Fuel tank is housed directly next to the infiltration basin. This should be relocated per pollution prevention measures.

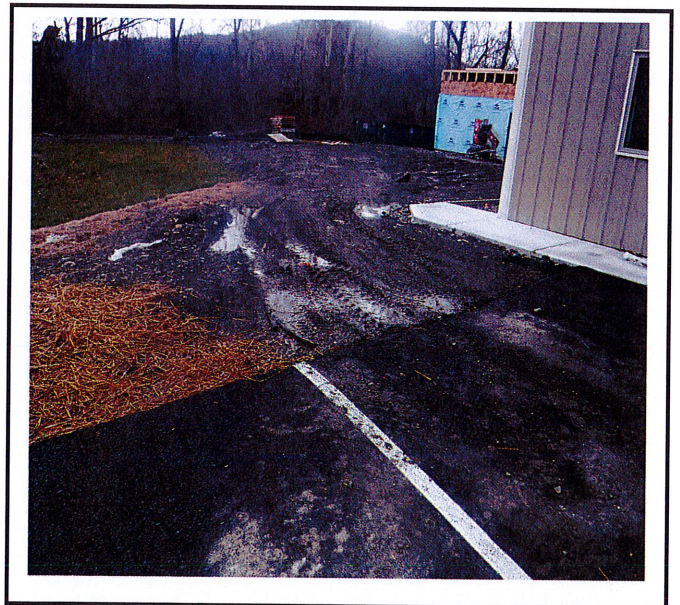
Work is continuing in close proximity to stormwater basin. Care should be taken not to discharge pollutants to the basin.

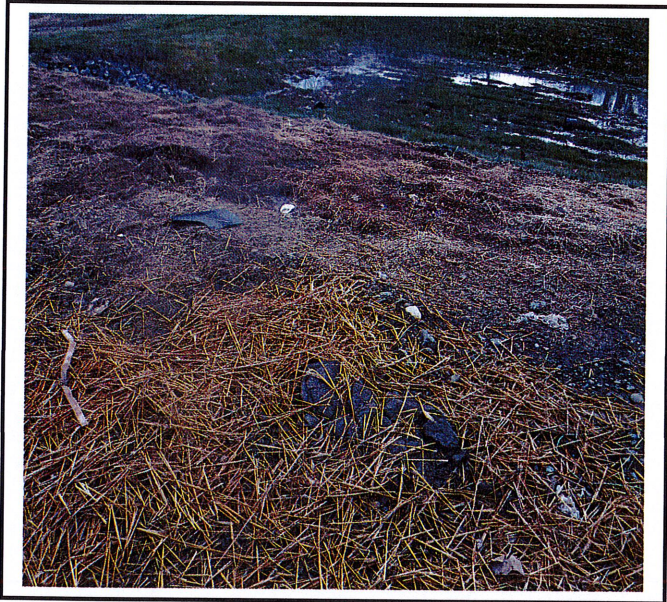
Piles of mortar on the ground needs to be cleaned up.

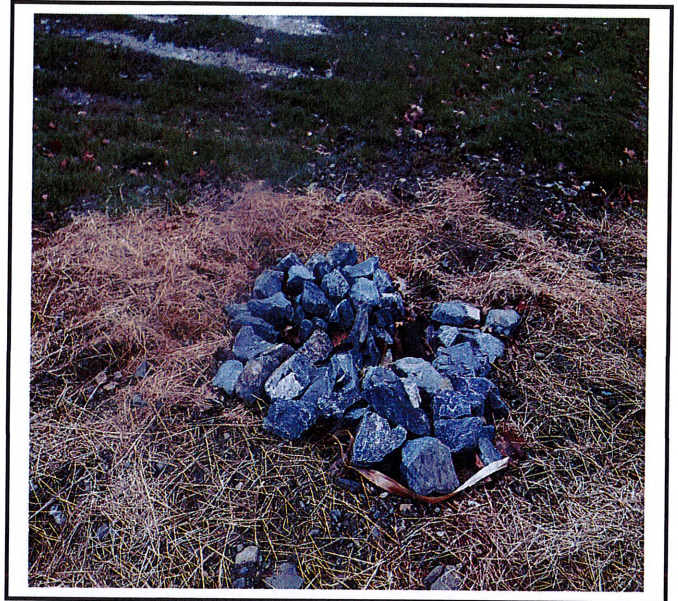
5. Rock outlet apron in the forebay is not built according to standard.

Rock outlet protection is not installed to approved SWPPP.

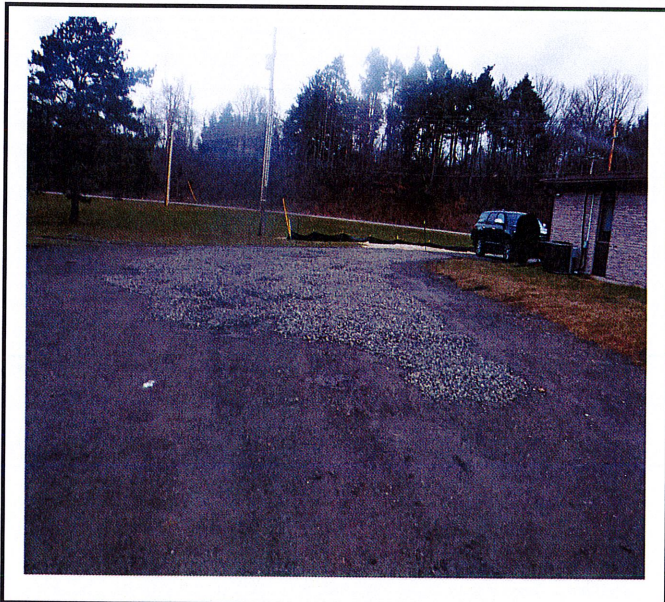
Fresh stone has been put down to prevent tracking.

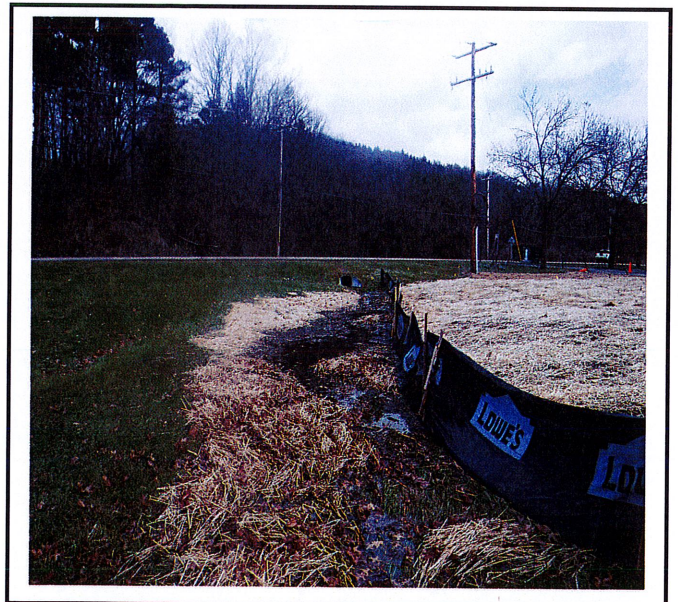
Open soil outside of approved work limits has been stabilized.
