**Chemung County Stormwater  
Construction Inspection  
Erosion and Sediment Control**

<b>Project Name</b> Fairport Ridge	<b>Date</b> 6-10-20
<b>Location</b> Prospect Hill Road Horseheads, NY	<b>Permit #</b> NYR11B687
<b>Weather Conditions</b> sunny warm	<b>Entry Time:</b> 9:06 am
<b>On-Site Representative Present:</b> Scott Mosso	<b>Exit Time:</b> 9:50 am

<b>PROJECT:</b>	Fairport Ridge
	Town of Horseheads
	Municipal Inspection
	June 10, 2020
<b>BY:</b>	Jessica Verrigni, CPESC, CPSWQ

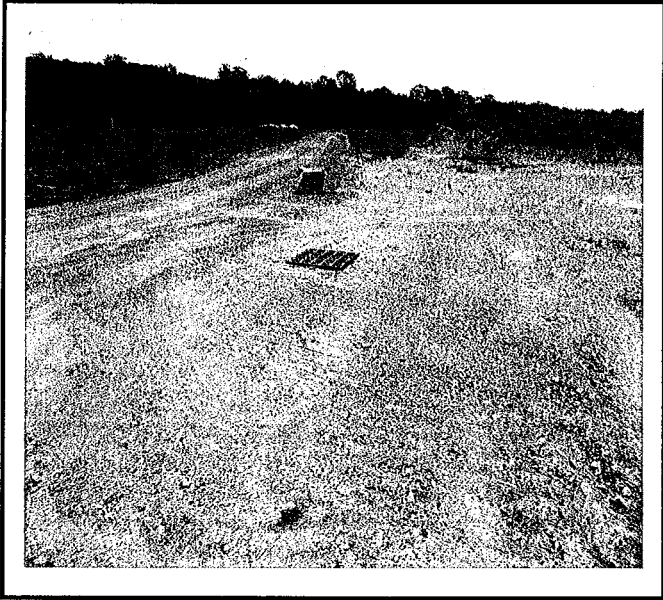
Catch basin needs protection around it.

<b>Corrections Needed:</b>			
-Catch basin protection is required around the two closest to the blacktop. Photos submitted from contractor-work completed.			
-Area behind the first house built needs stabilization.			
-Side slope of pond is eroding. Protections need to be placed to keep the sediment out and stop the erosion. Photos submitted from contractor-work completed.

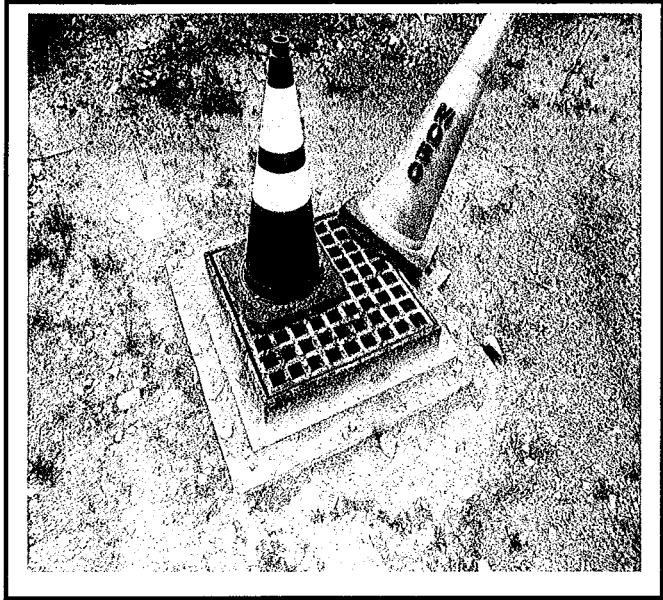
Catch basin needs protection around it.
