Chemung County Stormwater
Construction Inspection
Erosion and Sediment Control

Project Name Fairport Ridge	Date 8-29-17
Location Prospect Hill Horseheads NY	Permit #NYR11B687
Weather Conditions cool, overcast	Entry Time: 10:40
On-Site Representative Present: Scott Moss-owner	Exit Time: 11:15

PROJECT:	Fairport Ridge Town of Horseheads Municipal Inspection August 29, 2017
BY:	Jessica Verrigni, CPESC, CPSWQ

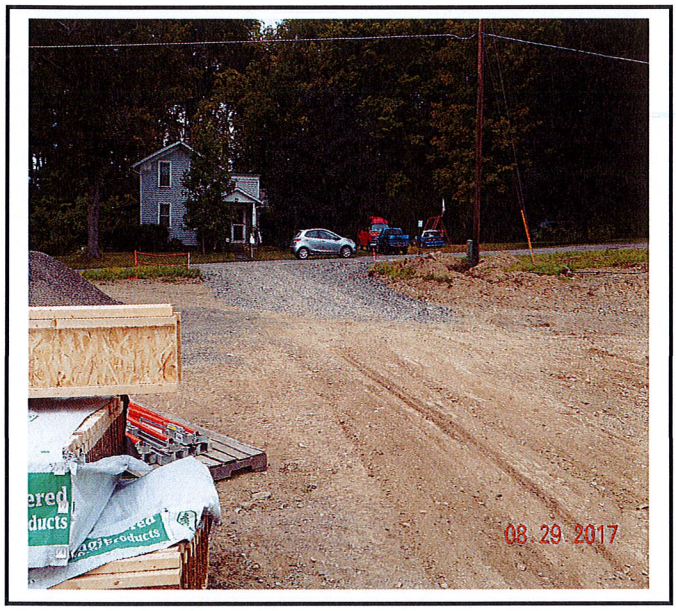
Construction entrance installed.

Topsoil stockpiles.

Silt fence installed.

Concrete trucks are washing into basement of Building 7.
