**Chemung County Stormwater
Construction Inspection
Erosion and Sediment Control**

Project Name Villa's at Gardner Road			Date 3-18-2020	
Location Lynhurst Ave, Horseheads (V), NY			Permit # NYR11P622	
Weather Conditions sunny			Entry Time: 1:28 pm	
On-Site Representative Present: None			Exit Time: 1:36 pm	
Construction Site Notes:				
-No work is occurring at the site at this time. Work has stopped on the home construction.				
-THIS SITE HAS COMPLETE FAILURE TO IMPLEMENT APPROVED SWPPP				
Yes	No	N/A		
	X		All erosion and sediment control measures installed/constructed	
	X		All erosion and sediment control measures maintained properly	
	X		Are there currently more than 5 acres disturbed w/o prior approval	
	X		Have stabilization measures been initiated in inactive areas	SEE NOTE
X			Are permanent stormwater control measures being implemented	
	X		Was there a discharge into the receiving water on the day of inspection	
	X		Evidence of turbidity or oil in the receiving waters	
X			Are weekly inspections being performed?

PROJECT: Villa's at Gardner Road
Village of Horseheads
Municipal Inspection
March 18, 2020

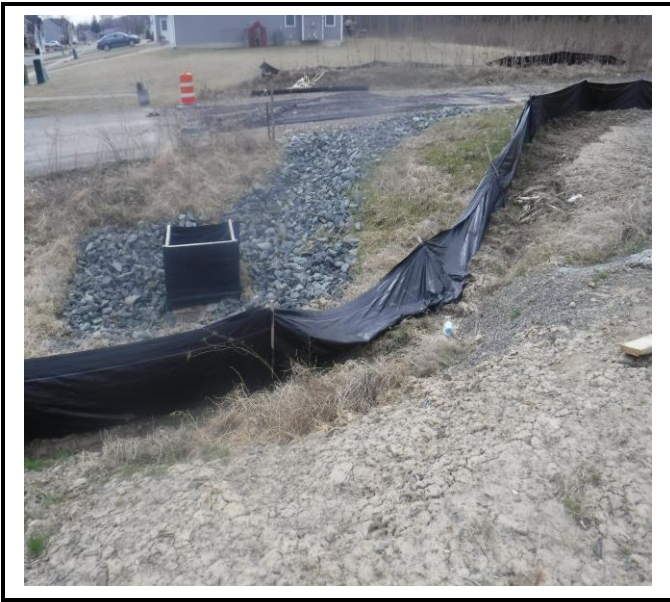
Silt fence- many areas of silt fence need replacement or maintenance.

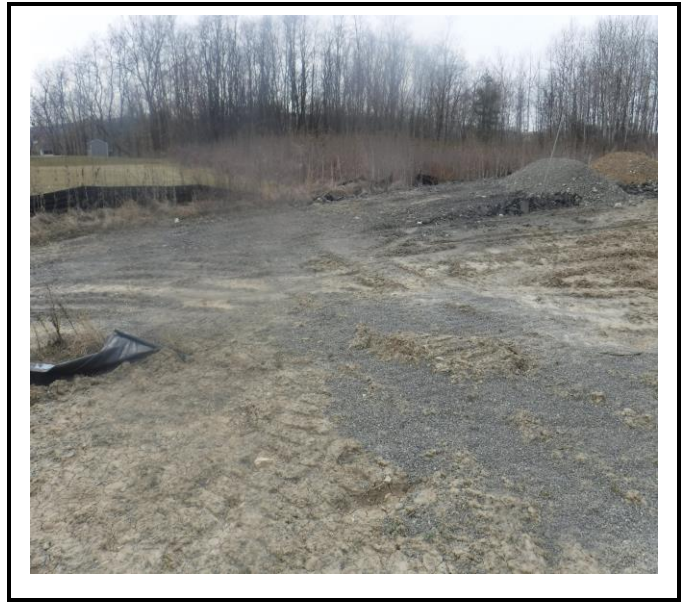
Construction Entrance- traffic is only supposed to enter and exit through stabilized construction entrances. Traffic is still bypassing these areas and tracking.

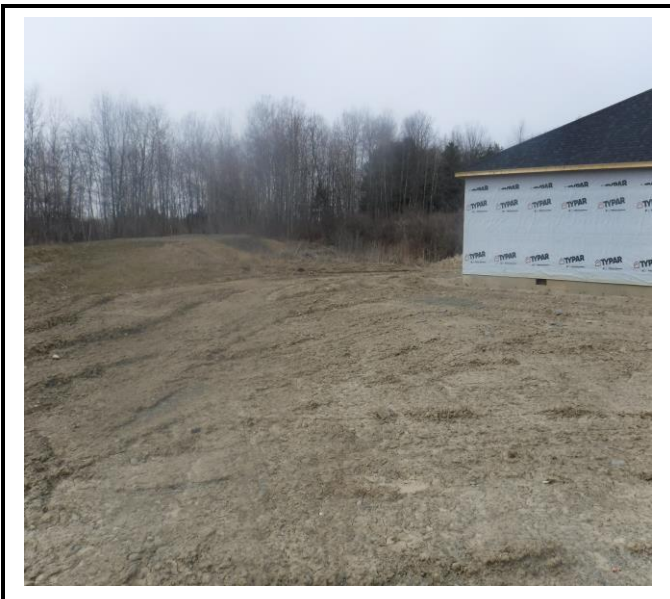
Soil stabilization- Any area that has bare soil not being worked for longer than 14 days requires stabilization. This soil has been exposed for months.

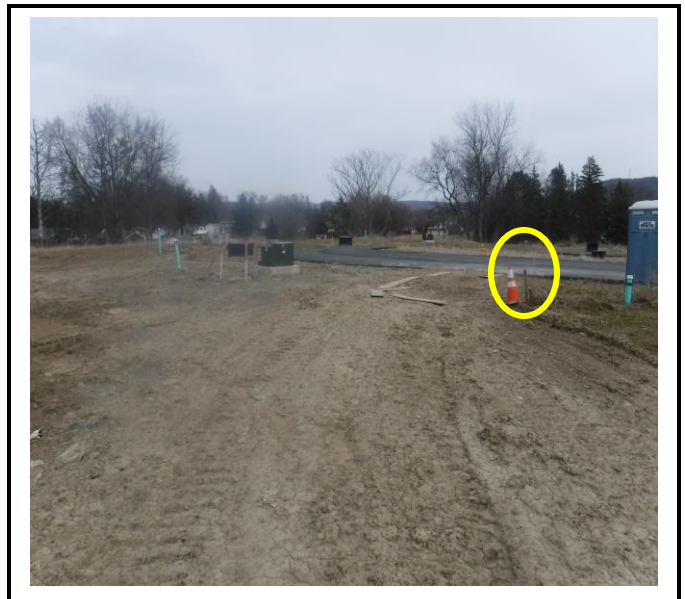
Work continues outside the limits of disturbance. These other lots are not approved for any disturbance at this time. See lot stake marker.

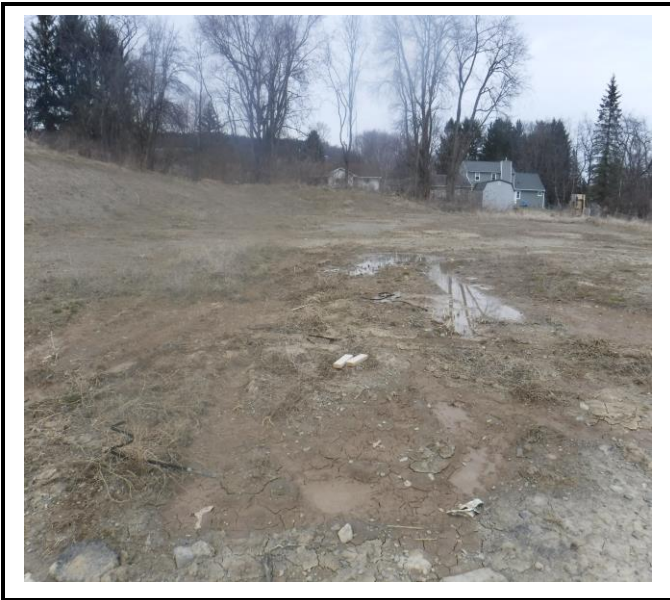
Driving and working in areas that are beyond the limits of disturbance of the 2 lots approved for work.

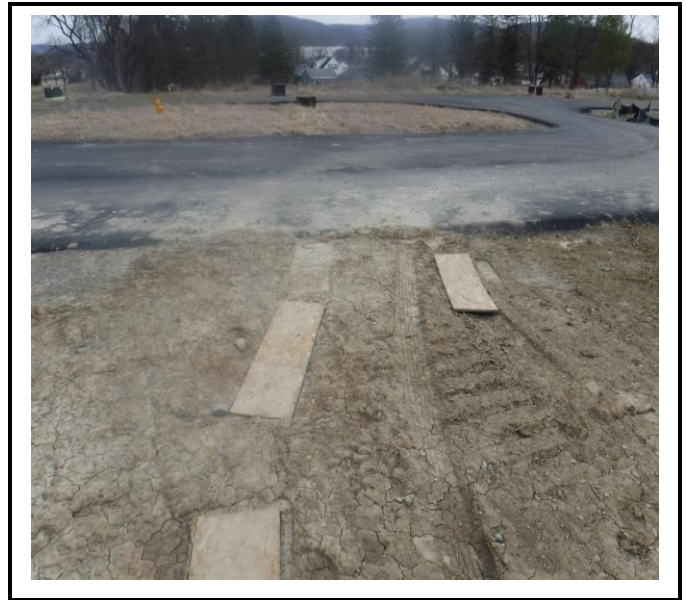
Vehicles accessing property outside of the limits of disturbance AND no construction entrance. You can see evidence of mud tracking onto the road.

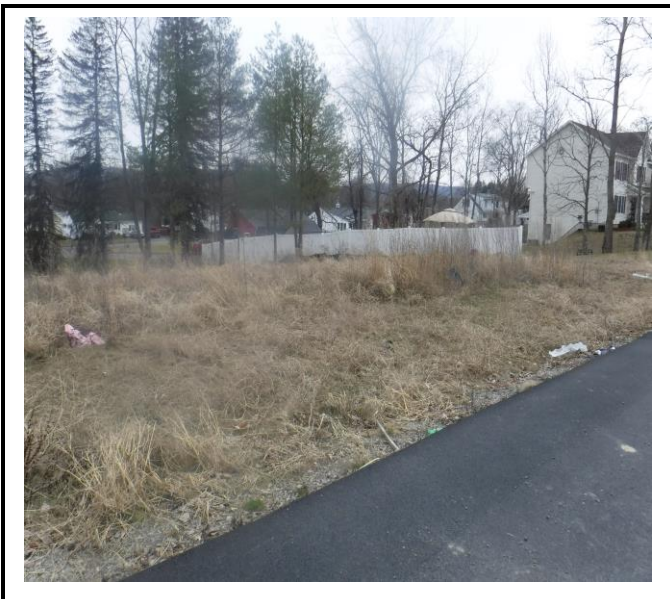
Construction debris and garbage blowing around the entire project area.

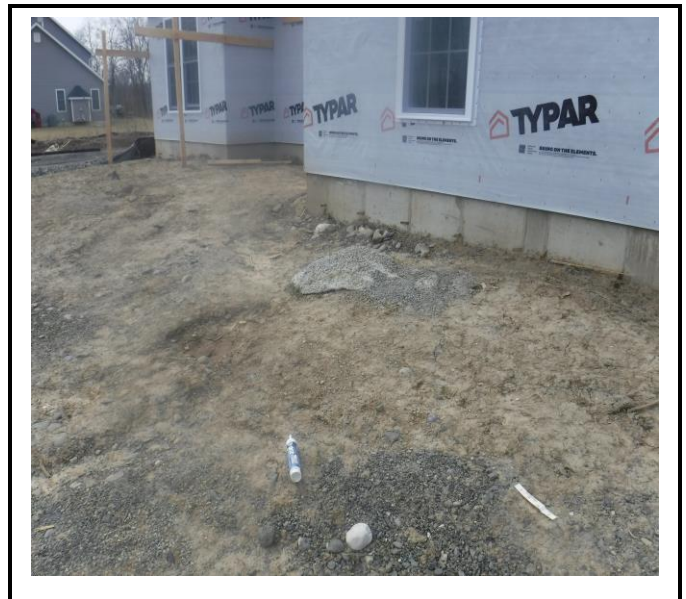
Concrete washout is all over the open lots. There is not one concrete washout on the open lots or any other.
