**Chemung County Stormwater
Construction Inspection
Erosion and Sediment Control**

Project Name Villa's at Gardner Rd	Date 6-30-26
Location Lynhurst ave horseheads, ny	Permit #
Weather Conditions overcast	Entry Time: 9:01 am
On-Site Representative Present: none	Exit Time: 9:12 am

PROJECT: Villa's at Gardner Road
Village of Horseheads
Municipal Inspection
June 30, 2020

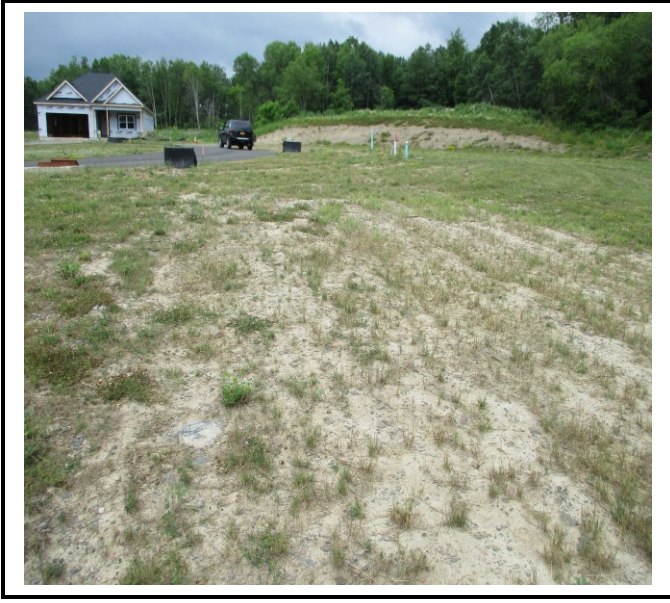
Soil needs to be stabilized.

Corrections Needed:			
-Soil stabilization is required in all areas where work is not occurring and soil can be seen. This could require scratching soil surface to prepare seed bed for vegetation to grow.			
-Silt fence needs maintenance on home lots.

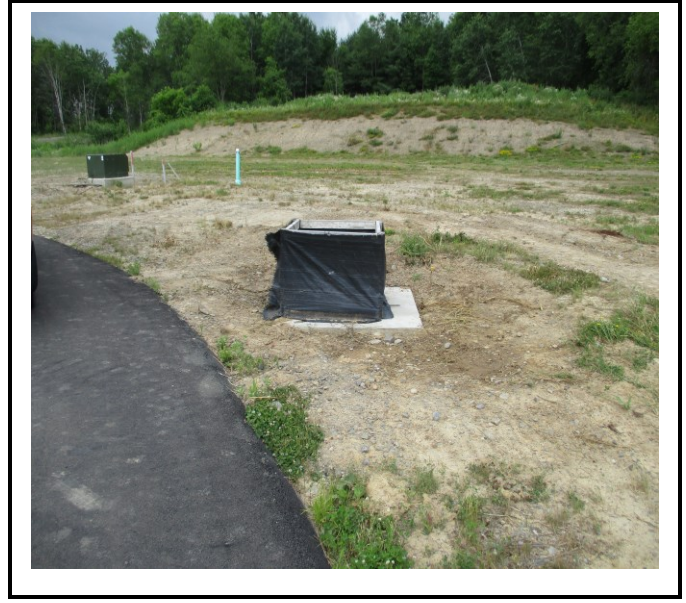
Soil stabilization needed.

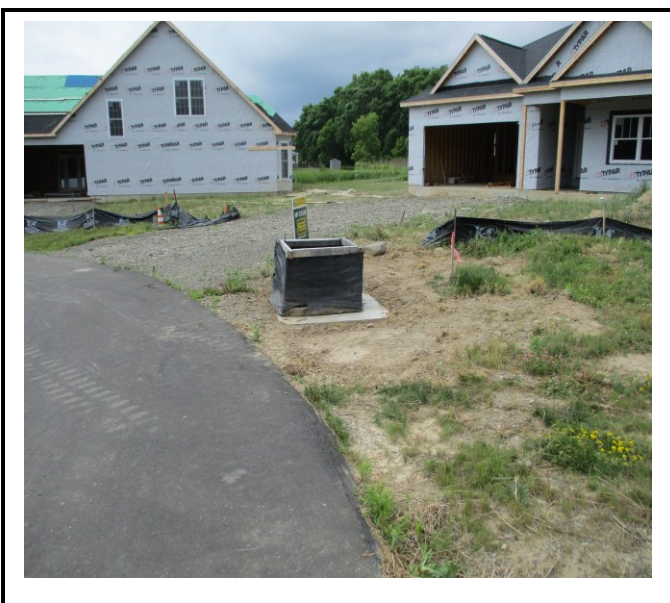
Catch basin tops have been replaced to lower and allow stormwater into them.

Construction Site Notes:			
			-2 homes under construction on open lots. No work is actively occurring.
			-Catch basins were lowered to allow stormwater into them. Village still wants one more lowered more.
