**Chemung County Stormwater
Construction Inspection
Erosion and Sediment Control**

| Project Name Villa's at Gardner Road | Date 11/3/2020 |

PROJECT: Villa's at Gardner Road
Village of Horseheads
Municipal Construction Inspection
November 3, 2020

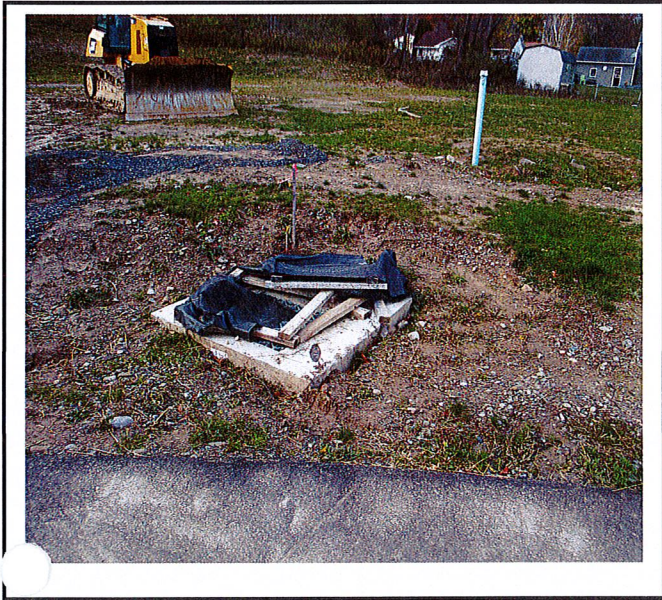
Catch basin protections need to be installed and functioning on all catch basins that are in exposed soil or active construction area.

| -Drop Inlet/catch basin protections need to be installed on all open exposed basins in areas not stabilized and during active construction. | | | |

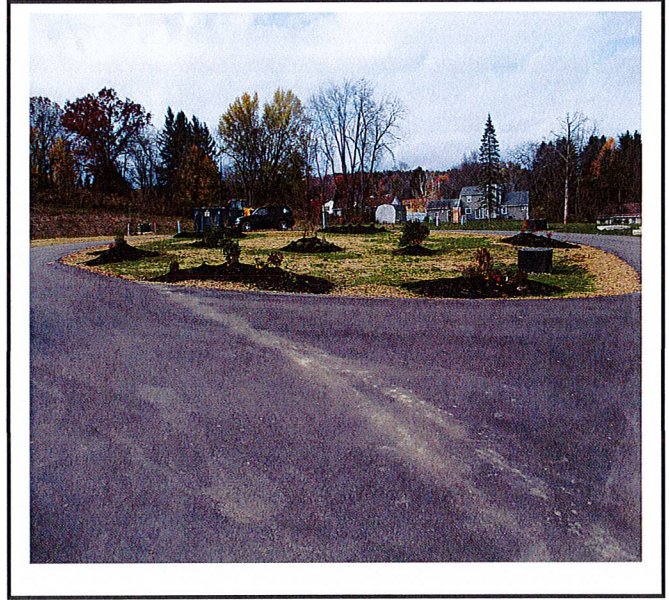
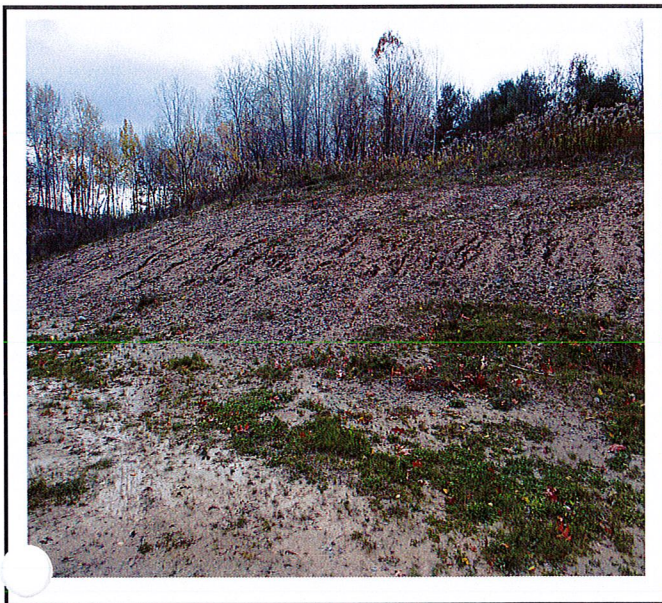
Steep slope needs to be repaired and seeded with a RECP blanket.

| -Steep slope behind houses needs to be regraded to repair the erosion and have seed and stabilization blankets added. | | | |

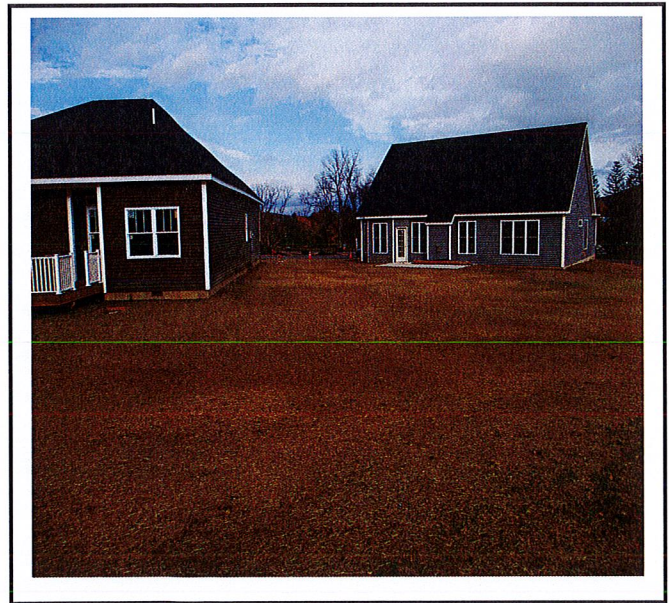
Areas around the house has been stabilized with seed and mulch.
