**Chemung County Stormwater  
Construction Inspection  
Erosion and Sediment Control**

<b>Project Name</b> Villa's at Gardner Road	<b>Date</b> 11-15-19
<b>Location</b> Lynhurst Ave Horseheads (V), NY	<b>Permit #</b> NYR11P622
<b>Weather Conditions</b> sunny, cold	<b>Entry Time:</b> 10:20 am
<b>On-Site Representative Present:</b> none	<b>Exit Time:</b> 10:28 am

PROJECT: Villa's  
Village of Horseheads  
Municipal Construction Inspection  
November 15, 2019

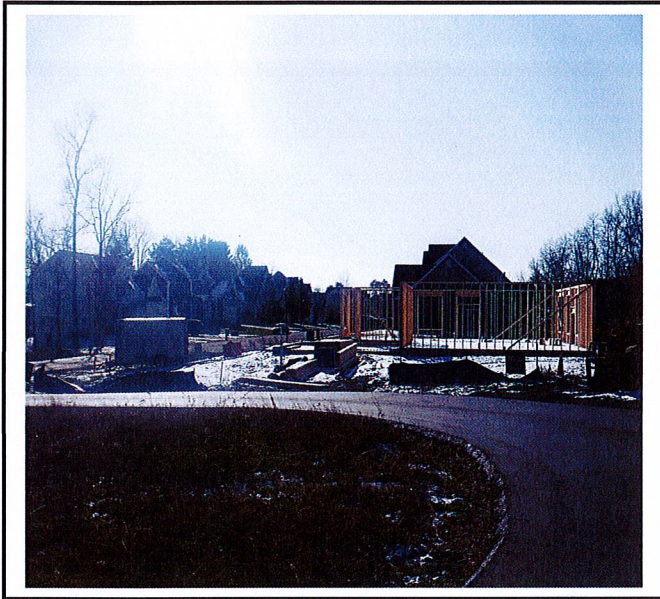
Silt fence needs replacement and repair all around Lot 10.

-Lot 10 silt fence requires maintenance and a construction entrance.

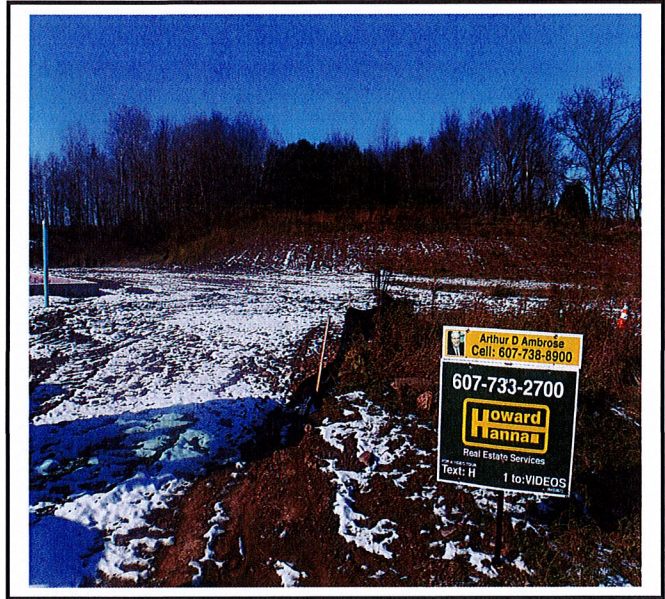
Lot 9 needs construction entrance and erosion and sediment control around entire lot.

-Lot 9 needs erosion and sediment controls. There is not silt fence around the site, no construction entrance and erosion is happening at the back of the lot.

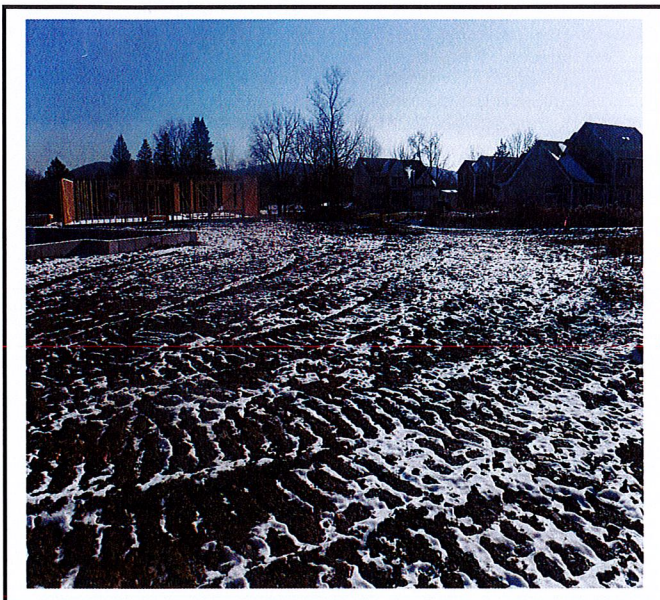
Back end of Lot 9 has no erosion and sediment controls.

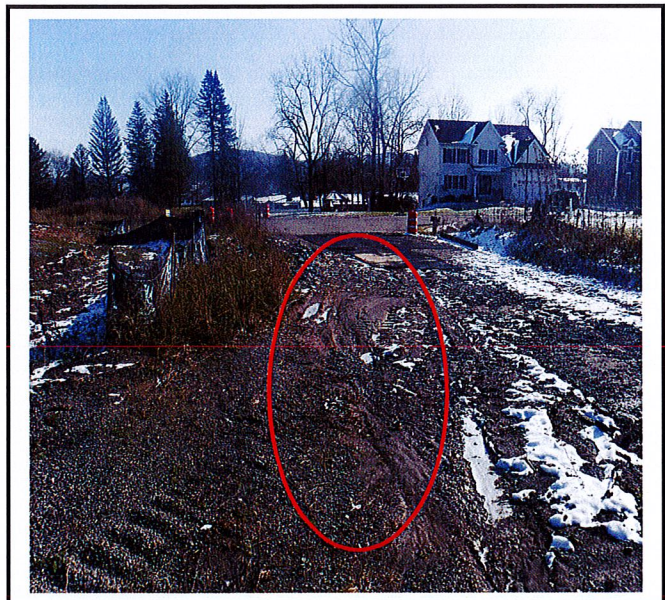
Sediment being carried off Lot 9

-Soil Stabilization is required of all open areas that are grading has ceased which is both building lots.
