**Chemung County Stormwater  
Construction Inspection  
Erosion and Sediment Control**

<b>Project Name</b> Villa's at Gardner Road	<b>Date</b> 12-11-2019
<b>Location</b> Lynhurst Road Horseheads (V), NY	<b>Permit #</b> NYR11P622
<b>Weather Conditions</b> sunny, cold	<b>Entry Time:</b> 9:51 am
<b>On-Site Representative Present:</b> None	<b>Exit Time:</b> 10:02

PROJECT: Villa's at Gardner Road  
Lynhurst Ave, Horseheads (V)  
Municipal Inspection  
December 12, 2019

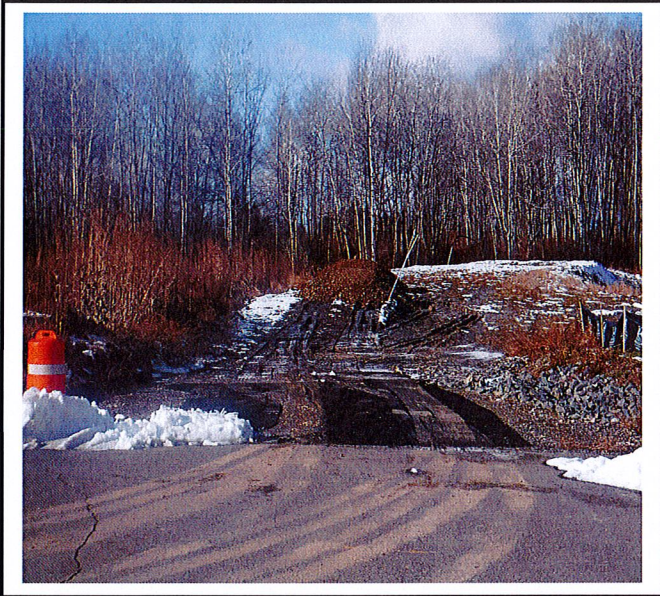
Mud is being tracked onto Lynhurst Ave from fill being dumped on future road. Construction entrance needed.

-Construction entrances need to be maintained on Lot 9& 10. A construction entrance needs to be installed at the area where the future road is being installed.

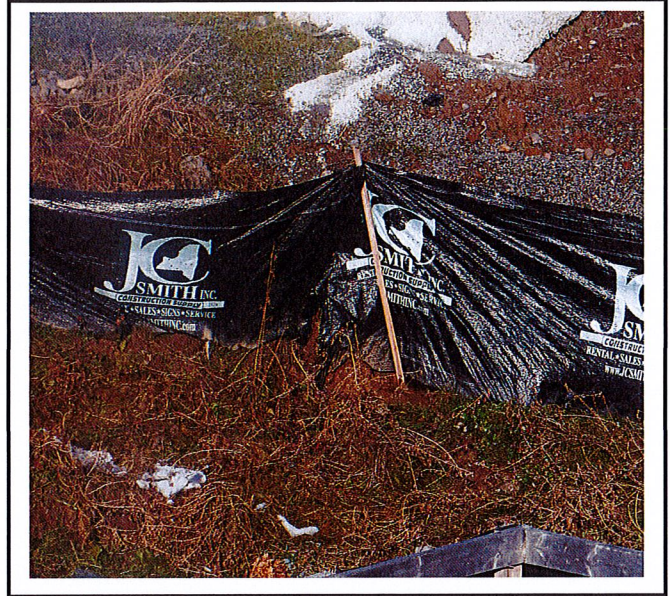
Silt fence requires maintenance and repair around the entire site.

-Silt fence is not maintained on both Lots. Silt fence needs to be re-installed and maintained throughout the project.

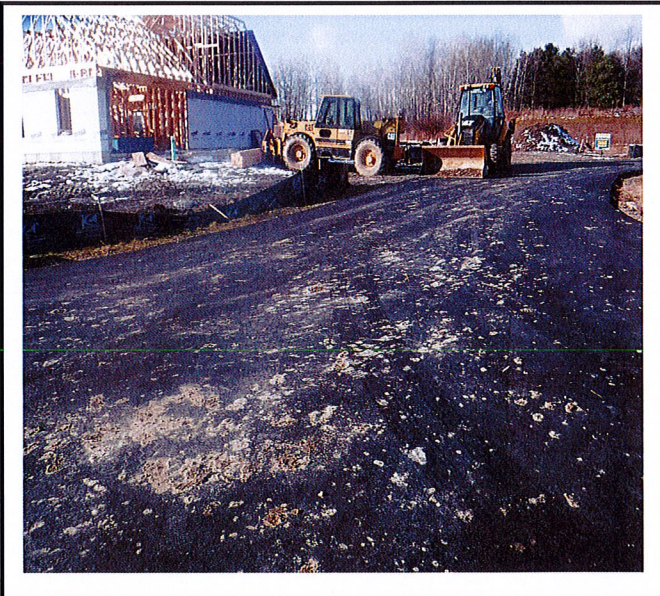
Construction entrances on both open lots need maintenance.

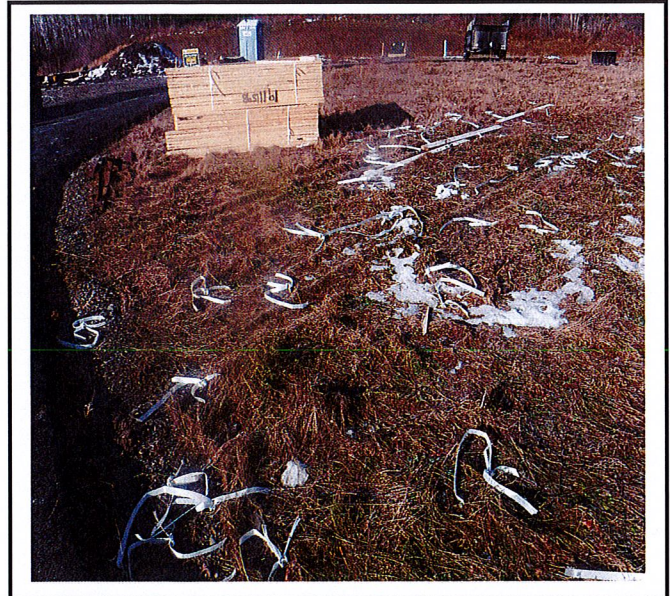
Garbage and debris around site needs to be cleaned up.

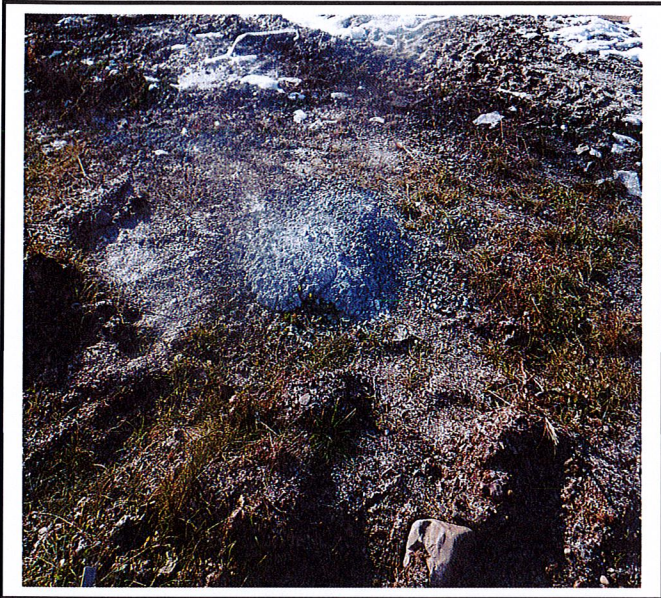
Concrete washed onto the ground. Concrete washout needs to be installed.

-Concrete washout needs to be installed. There is concrete washed out all over the ground.

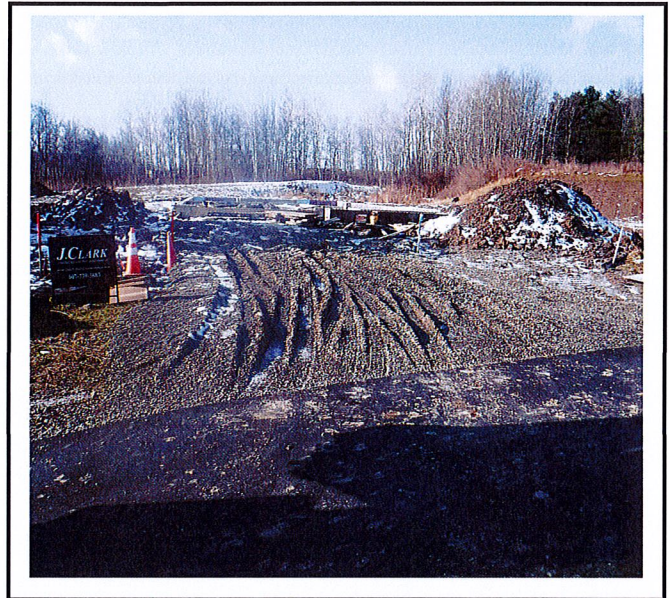
Topsoil pile needs to be stabilized. Construction entrance needs maintenance.

-Soil stabilization is needed on the stockpiles on the lots and that are close to stormwater basin where rock trucks backed down to deliver rip-rap.

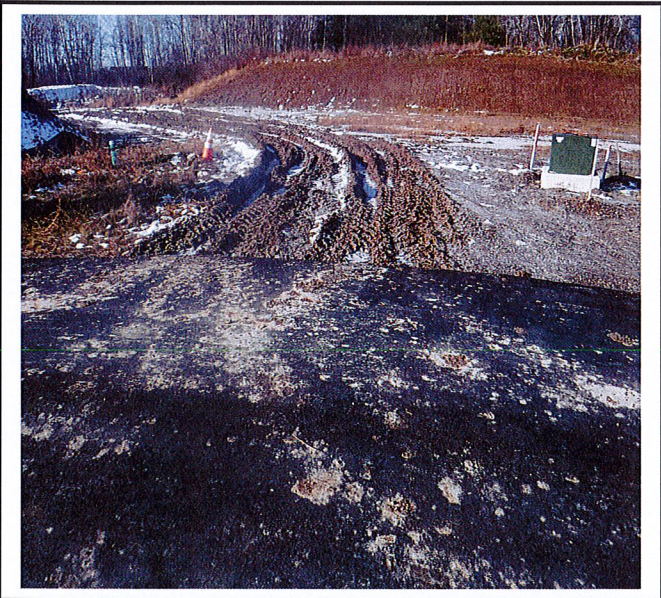
Construction vehicles are driving outside of lots under construction and tracking mud everywhere.

-Construction equipment is driving on lots NOT under construction. They are getting rutted up and compacted. These lots will need to be restored.

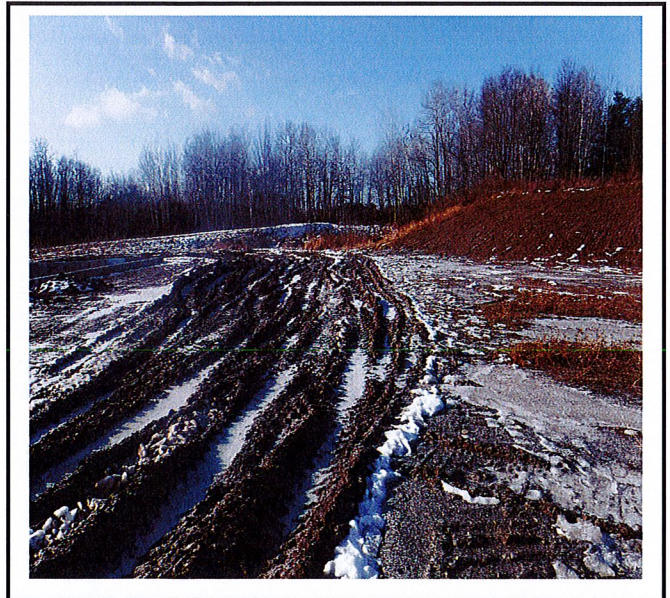
Construction vehicles are driving outside of lots under construction and tracking mud everywhere.
