**Chemung County Stormwater
Construction Inspection
Erosion and Sediment Control**

| Project Name Horseheads Hotel | Date 6-6-2022 |
| Location Circle Drive, Horseheads (V), NY | Permit # NYR10Y122 |

PROJECT: Horseheads Hotel
Village of Horseheads
Municipal Construction Insp.
June 2, 2022

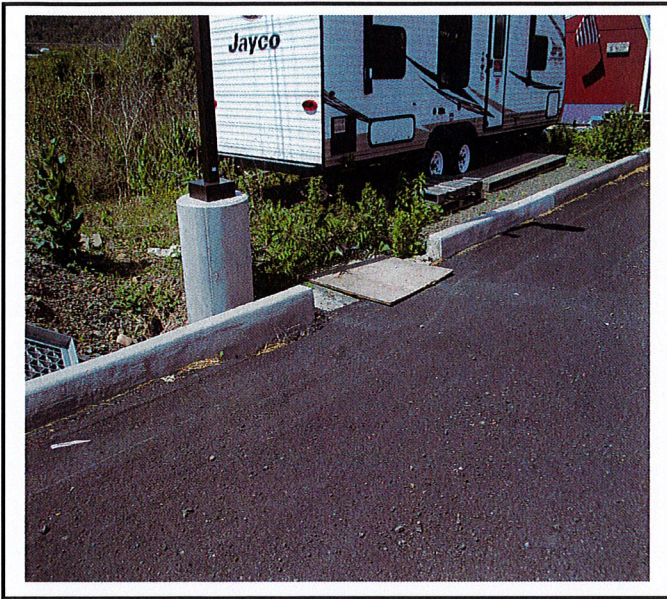
Concrete curb is not directing stormwater to the catch basin (under plywood).

| 3. | Concrete curb is broken and water does not get directed to the catch basin. The correction for this needs to be addressed by the owner and the consulting engineer. |

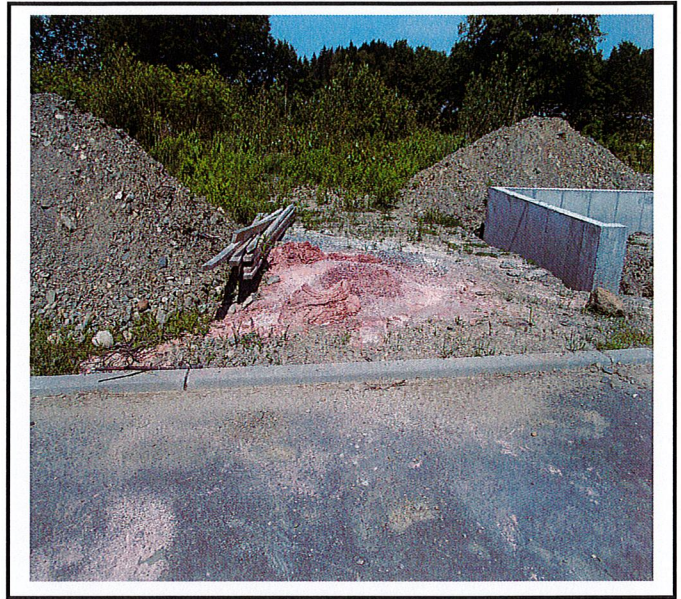
Concrete washed onto the ground.

| 2. | Concrete continues to be washed onto the ground and not into a concrete washout. |

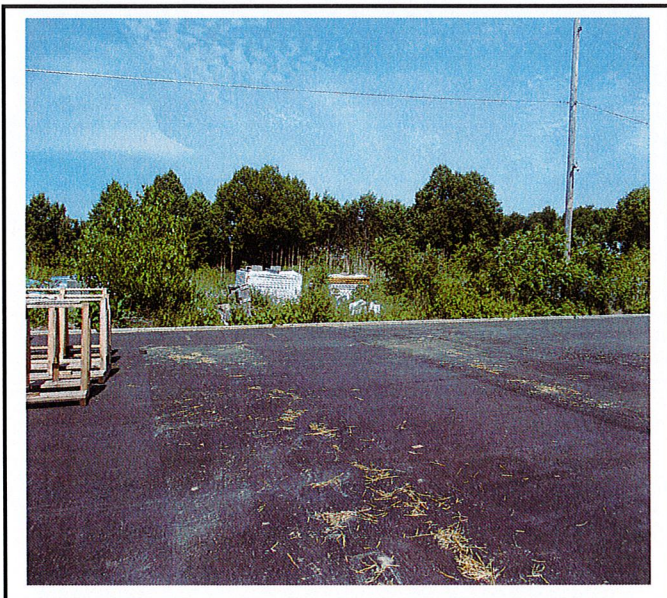
Woody vegetation growing around the stormwater basin.

| 4. | Woody vegetation, animal burrows, and material stockpiling is occurring around the stormwater basin. |
| This basin needs to be finished and cleaned up prior to final closeout. | |

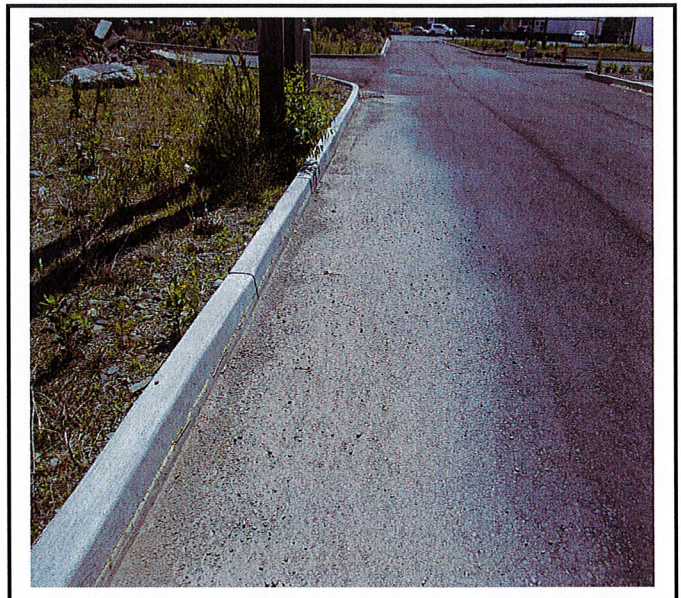
Sediment laden water is getting into the storm sewer.
