**Chemung County Stormwater  
Construction Inspection  
Erosion and Sediment Control**

<b>Project Name</b> Byrne Dairy	<b>Date</b> 11/1/2021
<b>Location</b> South Ave Elmira, NY	<b>Permit #</b> NYR111426
<b>Weather Conditions</b> cool, sunny	<b>Entry Time:</b> 1:55 pm
<b>On-Site Representative Present:</b> None	<b>Exit Time:</b> 2:06 pm

**PROJECT:** Byrne Dairy  
City of Elmira  
Municipal Inspection  
November 5, 2021

**BY:** Jessica Verrigni, CPESC, CPSWQ

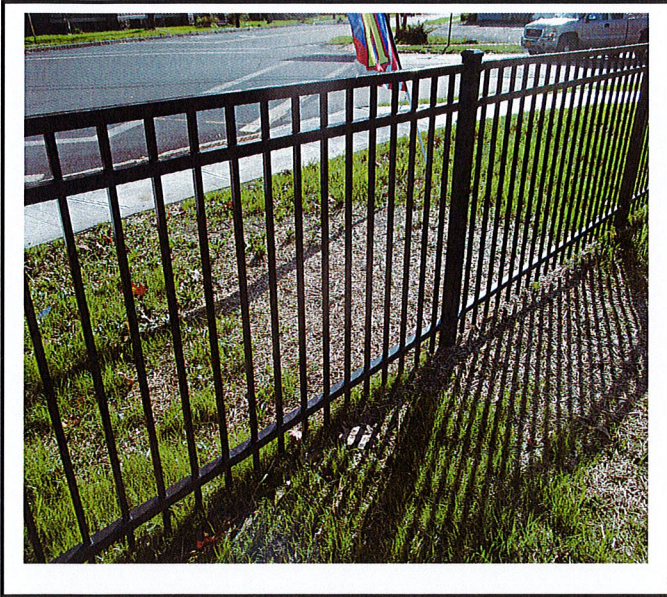
Areas not growing any grass may need to be addressed in the Spring 2022

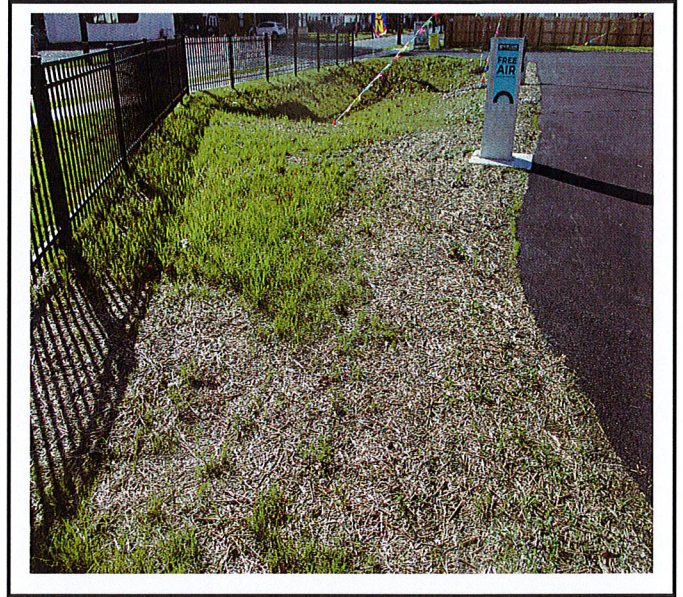
Areas not growing any grass may need to be addressed in the Spring 2022

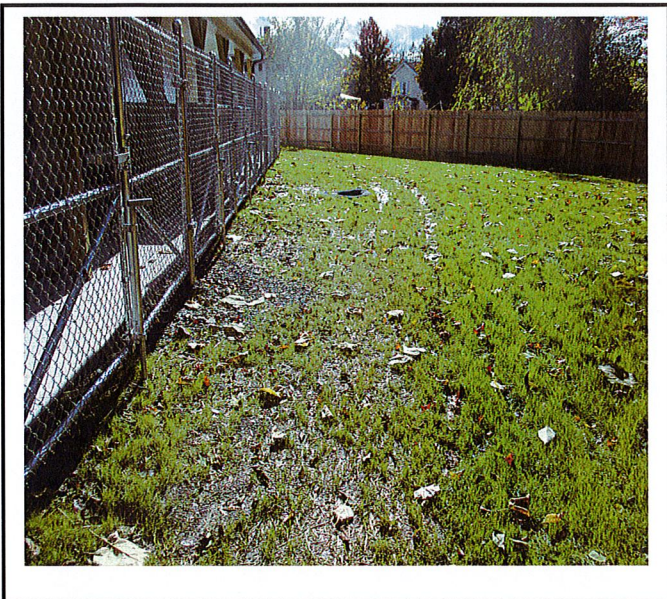
Looks like mowers are driving in this area when it is wet. They are rutting the area up and compacting the soil.

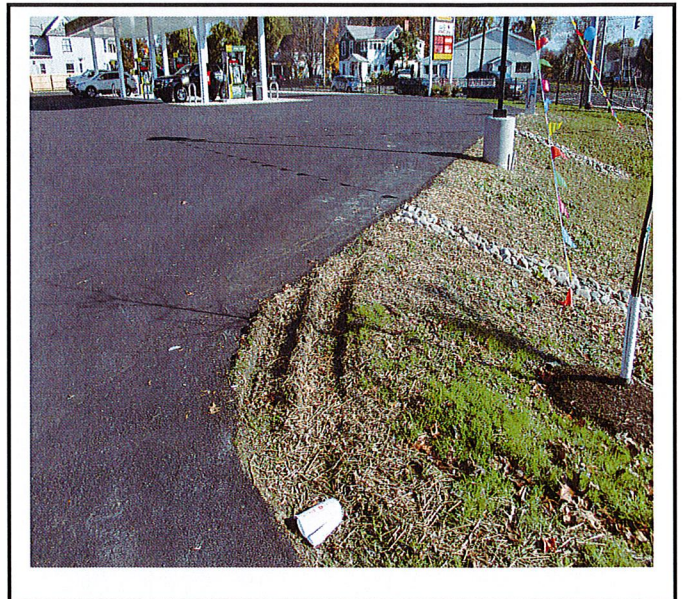
Grass is not growing in numerous areas which may need to be addressed in 2022. This includes all areas like this that could negatively impact drainage plan.

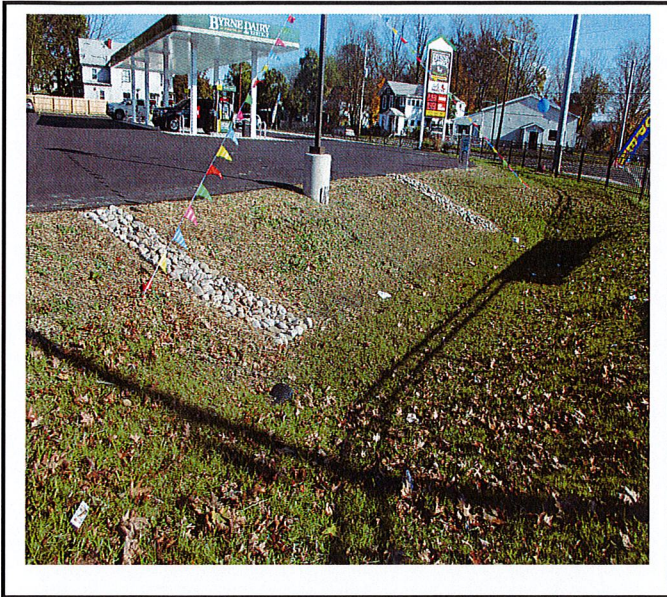
Areas not growing any grass may need to be addressed in the Spring 2022.

Corrections Needed:
-There are large areas around the infiltration basin and along Penn. Ave that there is minimal vegetation growing. These areas will most likely need help in the Spring of 2022.
-The rock channel at the south end of the infiltration basin is not located where approved within the SWPPP. The stones also look as though they sit higher than the pavement and water may flow around the channel.
-Behind the store is extremely wet due to the time of year. However, it appears some sort of small equipment continues to drive over it and further compact the soil. If this becomes an issue of grass not growing or a runoff issue it will need to be addressed.

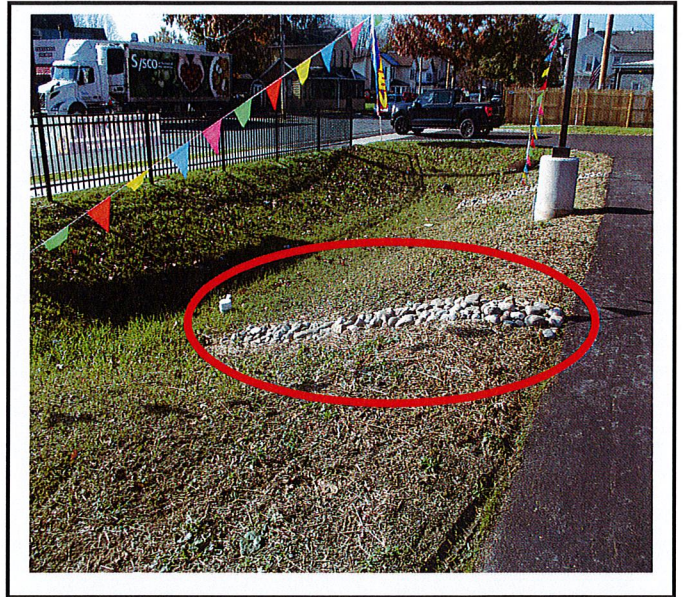
Rock channel is not shaped or located according to the plan. Also, rocks are placed higher than the pavement which may divert stormwater runoff.
