**Chemung County Stormwater
Construction Inspection
Erosion and Sediment Control**

Project Name Hilliard Warehouse Expansion	Date 8/13/2021
Location College Ave. City of Elmira	Permit #
Weather Conditions sunny, warm	Entry Time: 8:39 am
On-Site Representative Present: none	Exit Time: 8:50 am

PROJECT: Hilliard Warehouse Expansion
City of Elmira
Municipal Construction Inspection
August 13, 2021

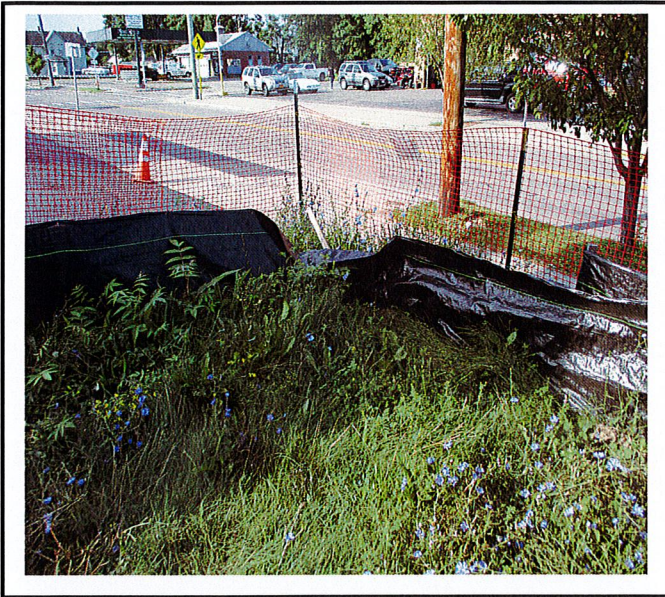
Silt fence needs to be stapled back to the post on the south west end of the building.

-Silt fence on the south west end of the building needs to be stapled back to the post.

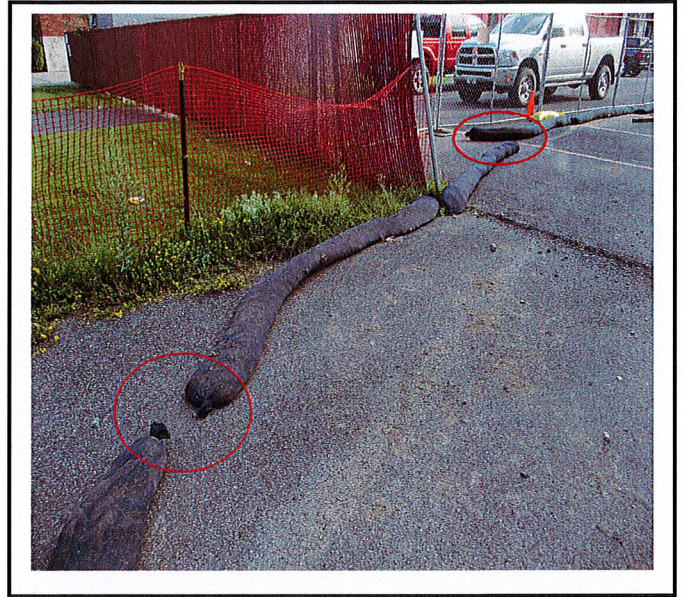
Compost socks need to overlap so water doesn't leave the project area.

-Compost socks at the north east end of the building need to overlap. It looks like they were moved and not put back correctly.

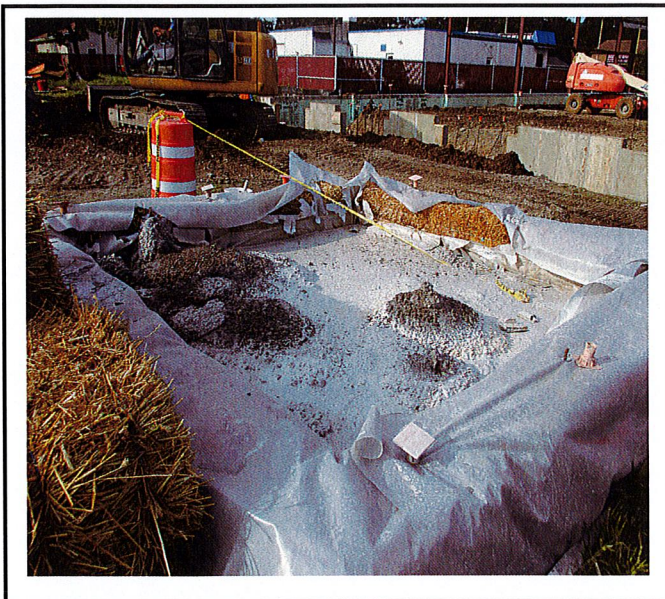
Concrete washout needs to be replaced. At the time of my visit they started working on removing this one in preparation of new wash pit.

-Concrete washout needs to be replaced. At the time of my inspection this was already being addressed.
