**Chemung County Stormwater
Construction Inspection
Erosion and Sediment Control**

Project Name Six67 Apartments	Date 8-11-2020
Location College Ave Elmira, NY	Permit # NYR11G564
Weather Conditions sunny, humid	Entry Time: 8:11 am
On-Site Representative Present:	Exit Time: 8:24 am

PROJECT: Six67 Apartments
City of Elmira
Municipal Construction Inspection
August 11, 2020

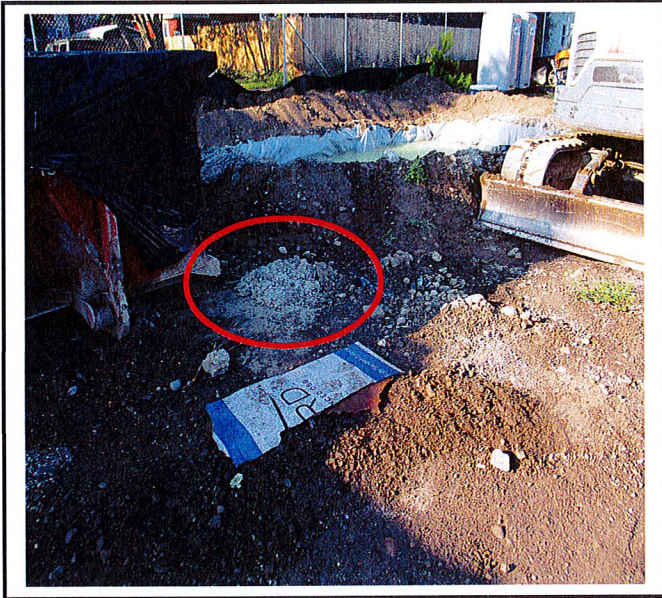
Not all concrete trucks are using the washout or getting it into the washout pit.

Corrections Needed:			
-Silt fence around the site needs maintenance. There are holes present, its knocked down and building materials are being placed on top of it.			
-Concrete trucks are not getting the washed material into the pit and others aren't even using the pit.

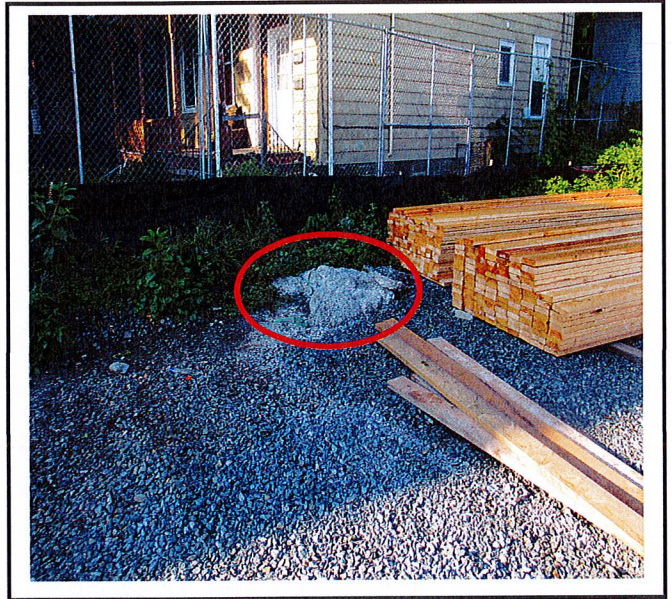
Not all concrete trucks are using the washout or getting it into the washout pit.

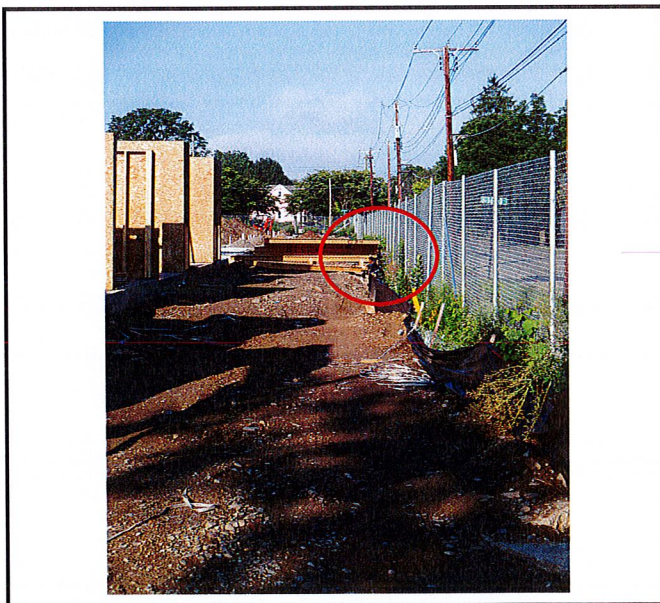
Silt fence is requires maintenance. It is down in some areas, encroached on in others and the building panels are on top of it in other locations.

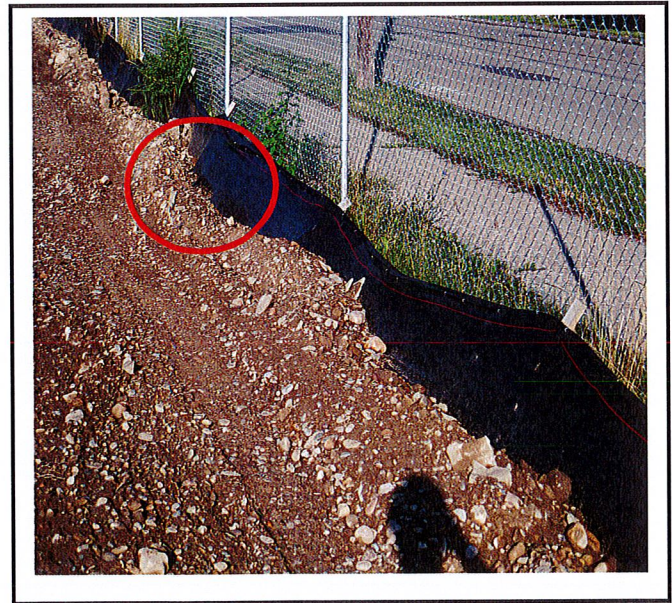
Silt fence has holes in it. It is being encroached upon with traffic around the building.
