**Chemung County Stormwater
Construction Inspection
Erosion and Sediment Control**

| Project Name Hilliard Building Expansion | Date 11-14-2019 |
| Location S. Magee Street Elmira (City), NY | Permit # NYR11F218 |

PROJECT: Hilliard Building Expansion
City of Elmira
Municipal Construction Inspection
November 14, 2019

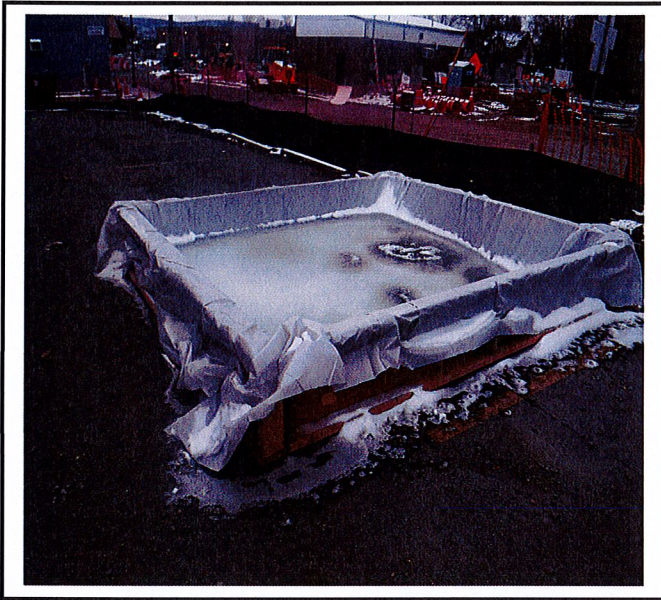
New concrete washout and new location.

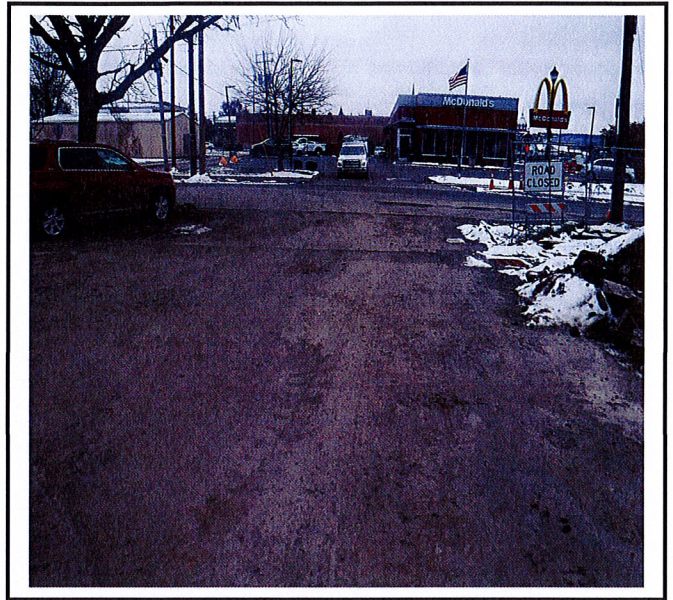
| | -Work continues on the building. There is not a lot of earthwork occurring. However, there is a tremendous amount of sediment on all paved areas. This sediment is tracking onto roads and getting into storm drainage. |

No construction entrance is installed and sediment is getting tracked off site onto W. 3rd street.

-Construction entrance is needed where traffic exits project onto W. 3rd Street. Tremendous sediment tracking. Sediment clean up is needed.

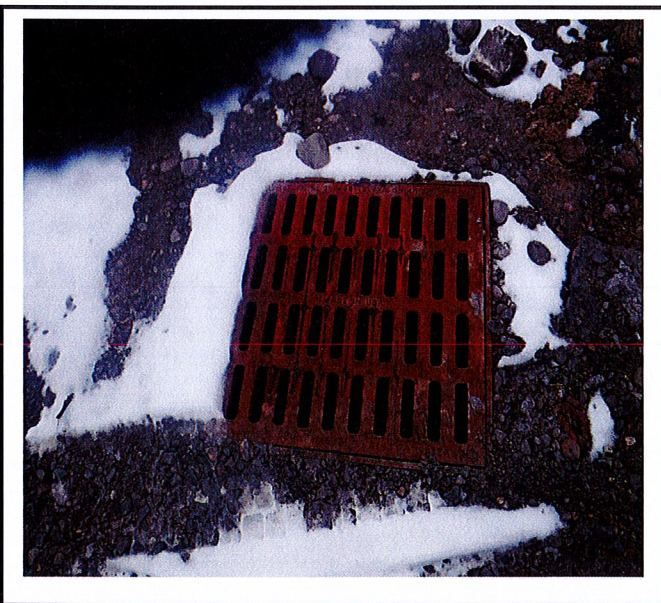
Unprotected catch basin near construction trailer and W. 3rd street.

-Stormwater catch basins around S. Magee Street and W. 3rd Street are not protected from sediment. Inlet protection required in SWPPP.

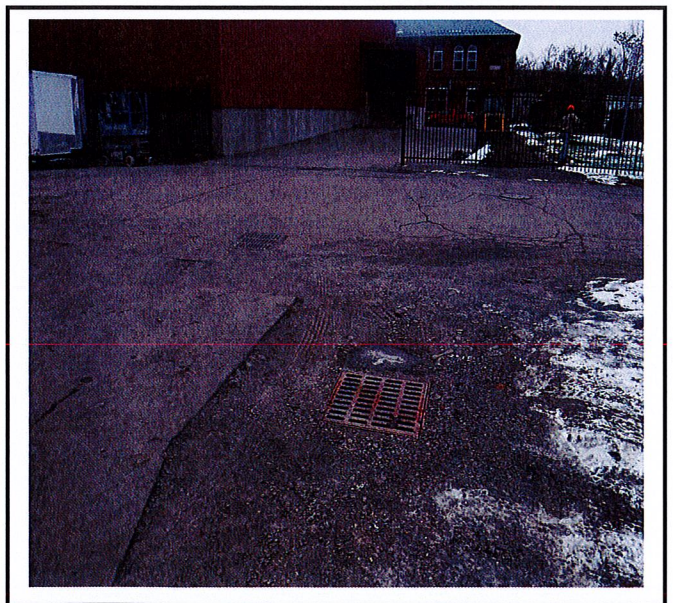
Unprotected catch basins from S. Magee Street and W. 3rd Street.
