**Chemung County Stormwater
Construction Inspection
Erosion and Sediment Control**

Project Name LECOM	Date 5-16-2019
Location College Ave, City of Elmira	Permit # NYR11 C547
Weather Conditions sunny, warm	Entry Time: 11:31 am
On-Site Representative Present: None available @ field office	Exit Time: 11:43 am

PROJECT: LECOM
City of Elmira
Municipal Construction Insp
May 16, 2019

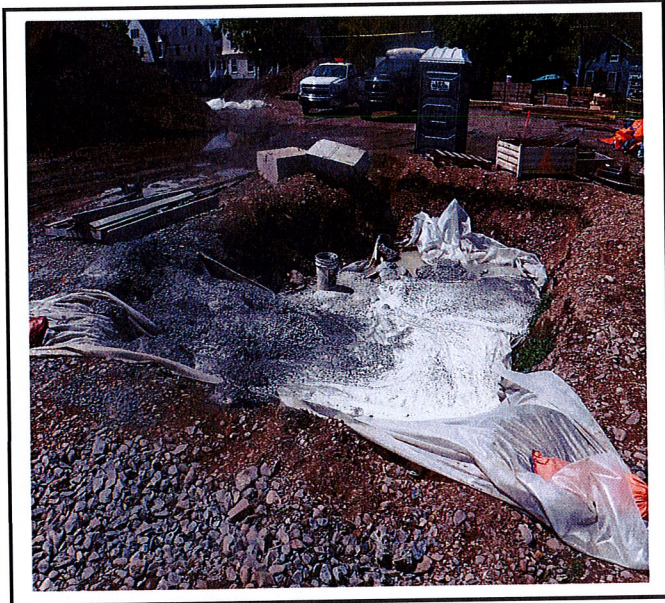
Concrete washout requires immediate maintenance.

-Concrete washout area requires maintenance. Plastic is no longer functioning and wash water is all over the ground surrounding the area. **This issue has been mentioned a number of times on Qualified inspection reports.**

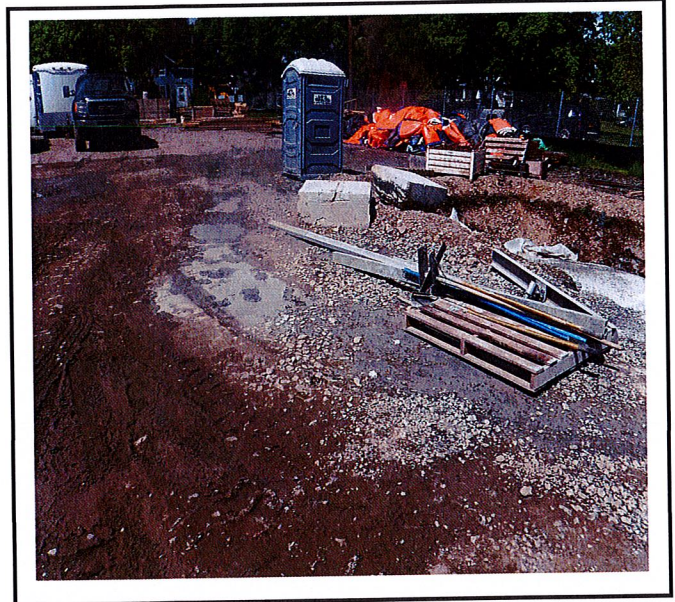
Concrete wash water all over the area surrounding the concrete washout.

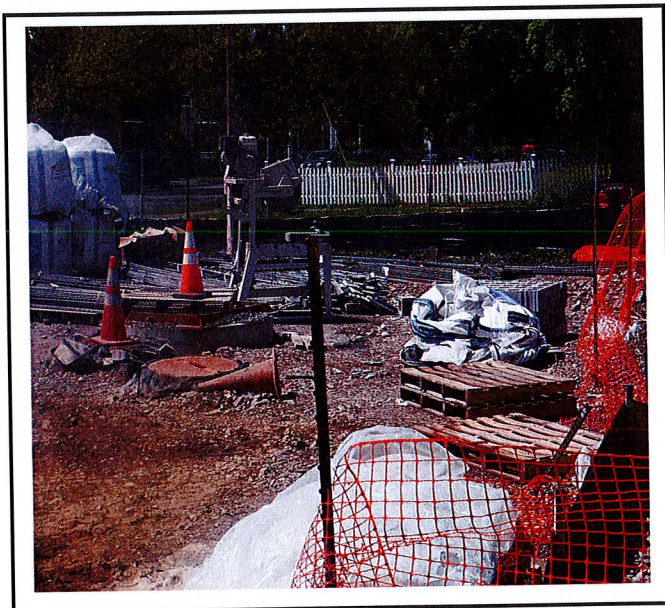
Water quality unit that is part of the underground stormwater facility is surrounded by mortar mixing materials. SEE INSPECTION NOTES

-Water quality unit that is part of the underground stormwater system is surrounded by the mortar mixing facility and materials. There is no lid on the unit. It only has a broken pallet and safety code on top of it. Mortar material could easily get into the unit and people could potentially dump materials down into it. This unit must be protected during construction especially from materials such as concrete and mortar.

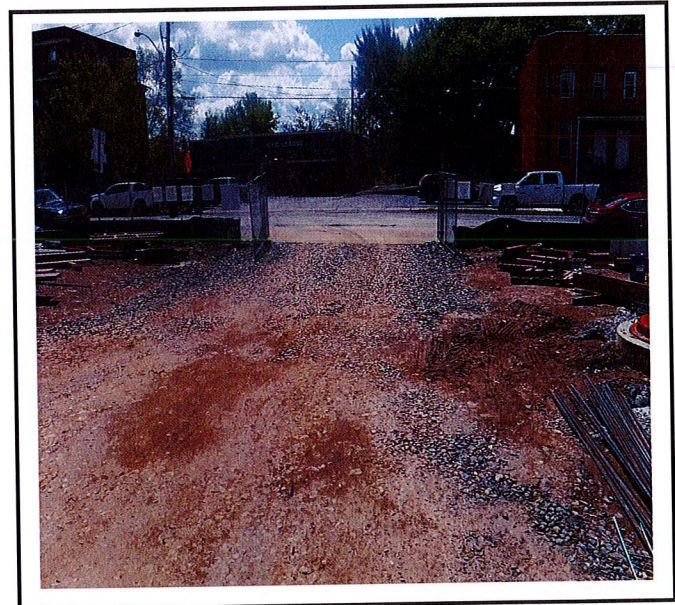
2nd Construction entrance requires maintenance.

-2nd construction entrance onto Clinton Street requires maintenance.
