**Chemung County Stormwater  
Construction Inspection  
Erosion and Sediment Control**

<b>Project Name</b> CDS Monarch	<b>Date</b> 5-30-19
<b>Location</b> Maple Ave. City of Elmira	<b>Permit #</b> NYR11C547
<b>Weather Conditions</b> overcast, mild	<b>Entry Time:</b> 11:33 am
<b>On-Site Representative Present:</b> maintenance staff	<b>Exit Time:</b> 11:54

PROJECT: CDS Monarch  
City of Elmira  
Municipal Construction Insp.  
May 30, 2019

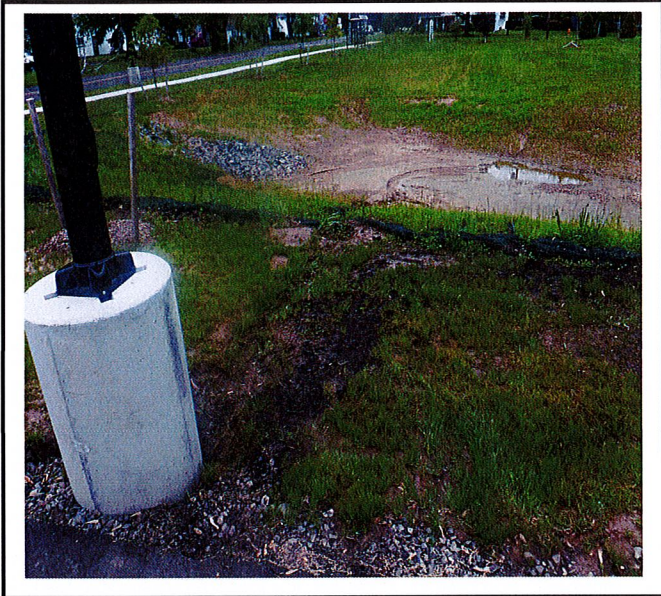
Erosion continues off from parking lot. Sediment will need to be removed form basin.

<b>Corrections Needed:</b>
-Major erosion is occurring off the parking lot into the forebay. This erosion needs to be repaired and sediment cleaned out of basin.
-Everywhere that compost sock was removed needs the mulch raked flat AND the erosion control blanket laid flat and re-stapled.
-Check dam in the basins are not installed correctly.
-Erosion is occurring around the catch basin on the north end of the property.
-Stabilization is not consistent around the property.
-All items noted in City letter dated 1/14/2019 need to be addressed.

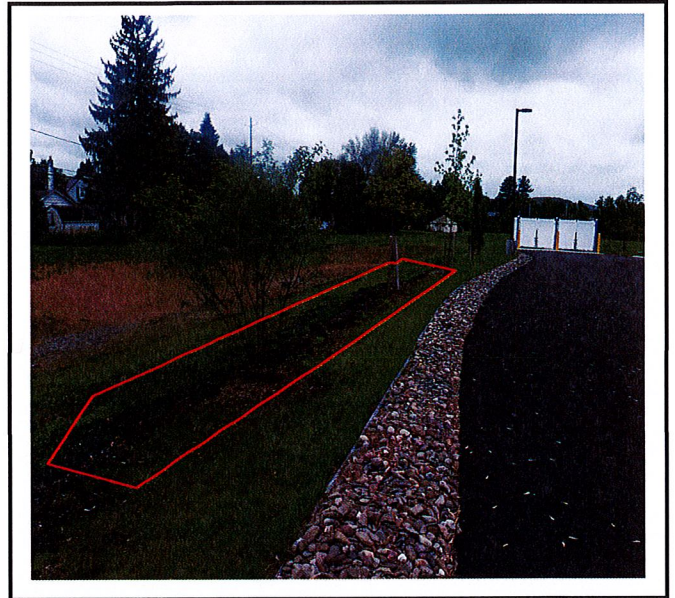
All areas where compost sock was removed need to be raked flat AND the erosion control blanket stapled flat onto the slope.

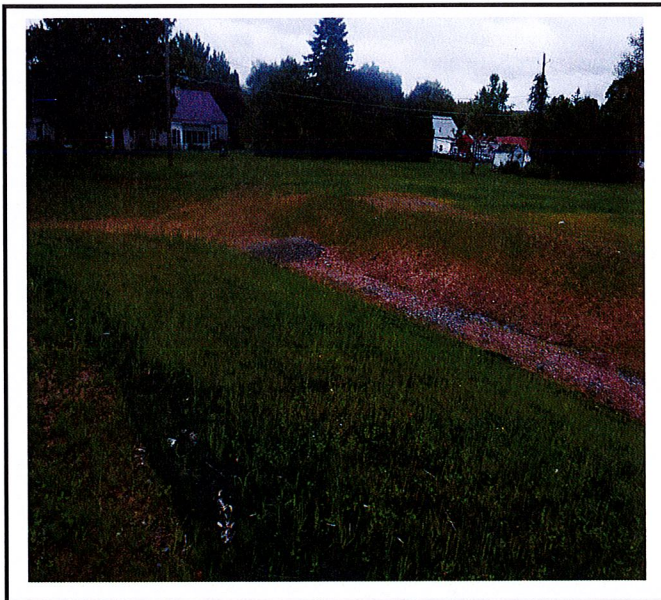
Check dams not installed correctly.

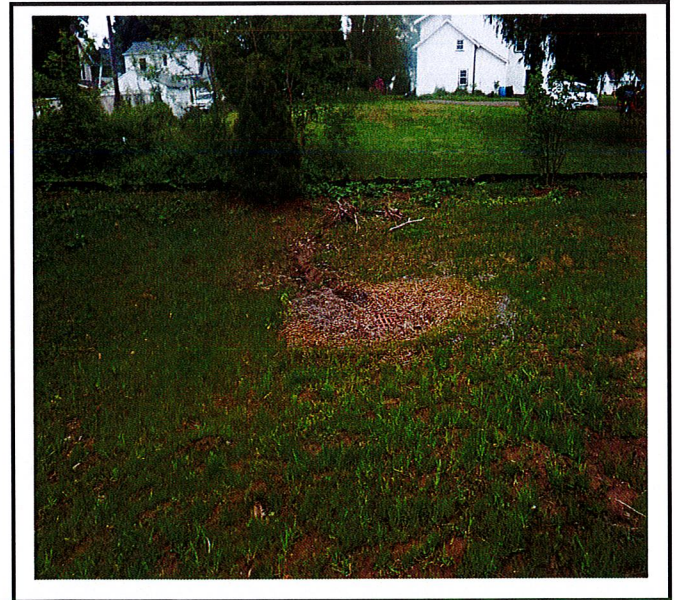
Erosion is occurring around catch basin. Grading needs correction.
