**Chemung County Stormwater
Construction Inspection
Erosion and Sediment Control**

Project Name Barrington West Lot #54	Date 4-11-22
Location Royal Court Horseheads, NY	Permit # NYR11F212
Weather Conditions sunny	Entry Time: 11:45 am
On-Site Representative Present:	Exit Time: 11:54 am

PROJECT: Barrington West Lot #54
Town of Horseheads
Municipal Inspection
April 11, 2022

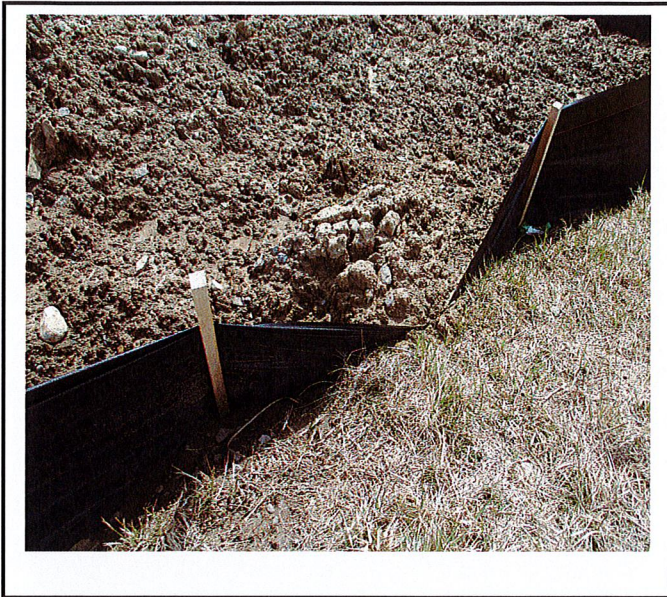
Soil is overtopping the silt fence. Remove soil and repair silt fence.

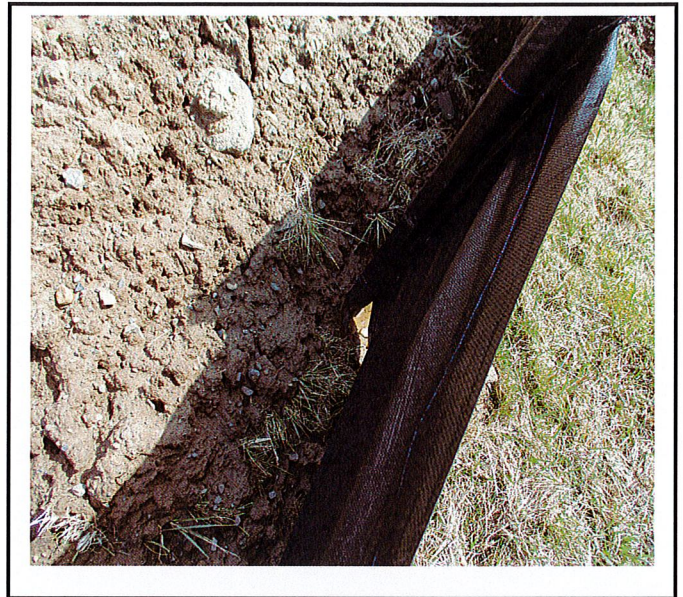
Silt fence not properly toed into the ground.

Corrections Needed:	
-Silt fence along downslope property requires maintenance.	
-Open soil areas where work is not occurring requires temporary stabilization.

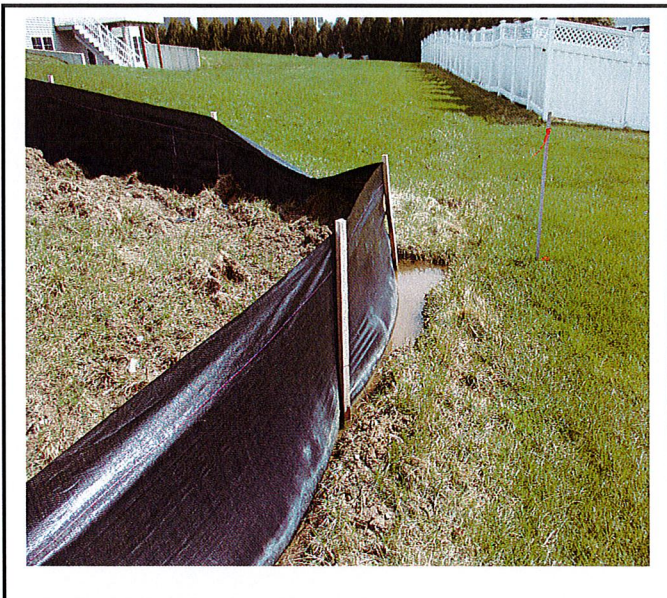
Drainage issues already a cause of concern.

Construction Site Notes:	
-Drainage at the rear of the property continues to be a concern. There is not standing water between the two properties and impervious surfaces don't exist yet.

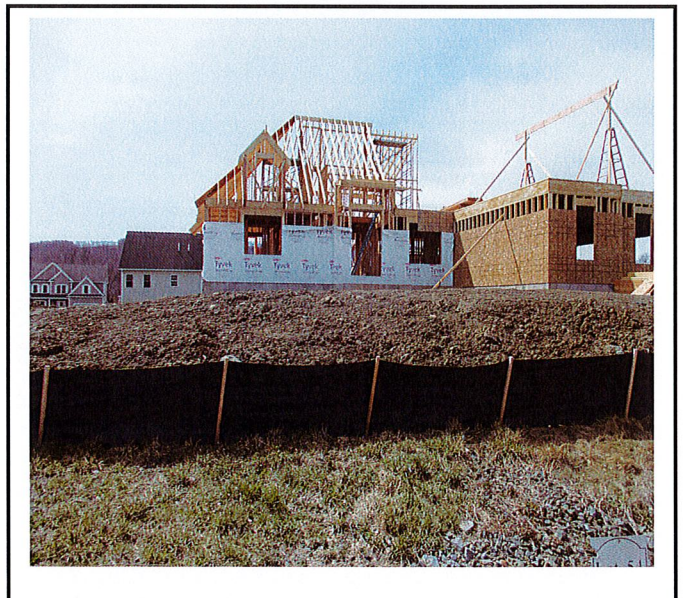
Soil is not being actively disturbed at this time-stabilization required.
