**Chemung County Stormwater
Construction Inspection
Erosion and Sediment Control**

Construction Site Notes:	
	-Building is under construction.
	-Gas tanks going in with underground drainage.

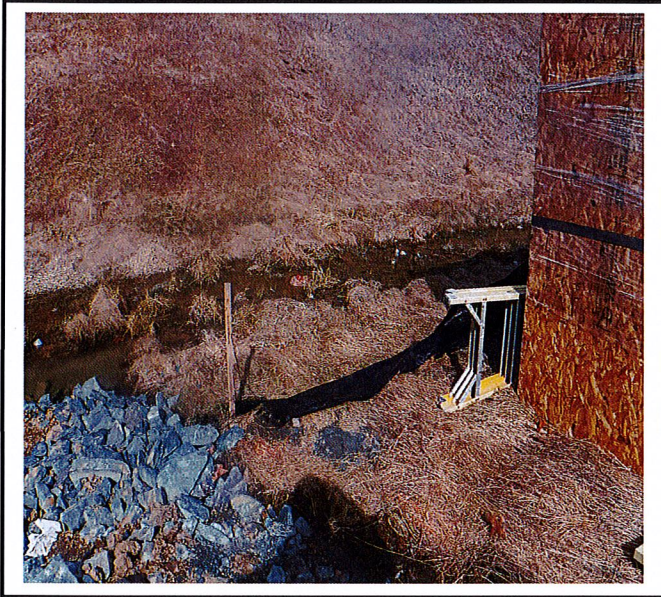
Silt fence requires repair.

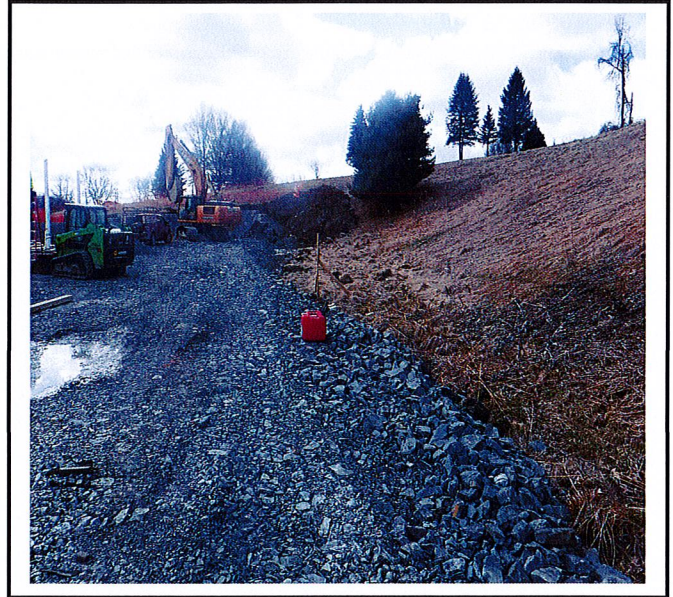
Gas cans are left next to drainage ditch. If they were to spill it would be a problem. Follow Pollution Prevention measures.
