**Chemung County Stormwater
Construction Inspection
Erosion and Sediment Control**

Project Name Glad Tidings Building Exp	Date 10-16-18
Location 116 Breesport Rd Horseheads, NY	Permit # NYR11C743
Weather Conditions Sunny, cool	Entry Time: 10:15 am
On-Site Representative Present: Bruce Patoka, Bella Facia	Exit Time: 10:45 am

PROJECT: Glad Tidings Church
Town of Horseheads
Municipal Construction Inspection
October 16, 2018

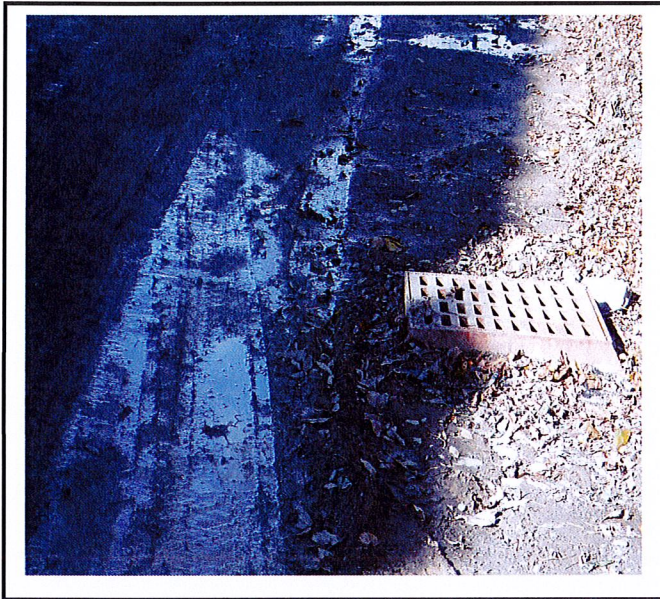
Catch basin protections have been removed from all catch basins.

-Catch basin protection has been removed in preparation for paving. Paving is not occurring for 2 weeks. Protections need to be in place. Consultant can suggest options.

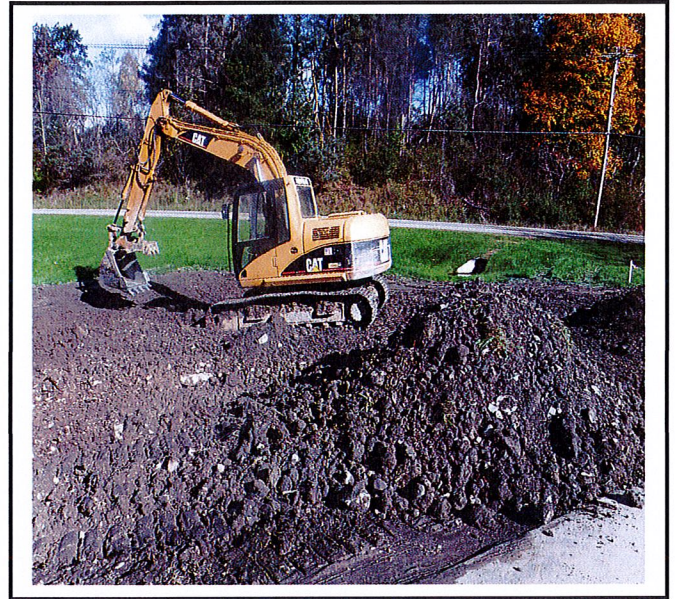
Contractor is working outside of the limits of approved SWPPP. Plans/ permit need to be updated and erosion and sediment control is required.

-Contractor is working outside of the approved SWPPP. In this are silt fence is required and stabilization. Also, the SWPPP needs to be updated to reflect the changes that have occurred.

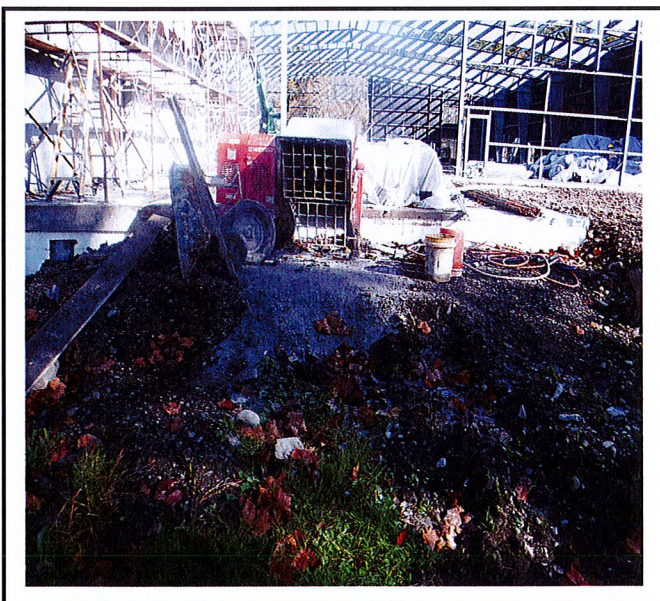
Mortar mixing area is tributary to the stormwater forebay. There are no protections in place. It appears runoff has been an issue. Correction needed

Corrections Needed: -Mortor mixing area not protected. Protections are required on this.

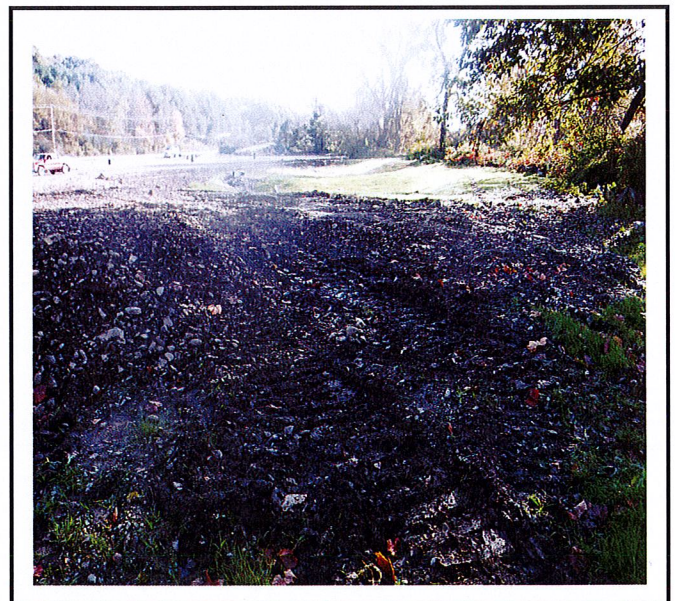
Areas have been graded around forebay and along infiltration basin.

-Grading has occured between parking lot and finalized infiltration basin. This exposed soil can not get into the basin. Sediment control and stabilization is required.

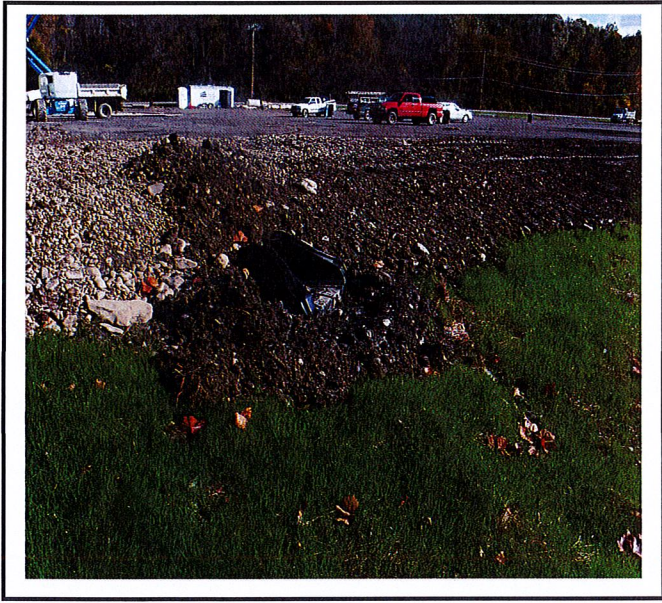
Outlet protection is not installed. Mud has been placed around the storm pipe.

-Outlet protection not isntalled on forebay storm sewer. Mud has been placed in this area and will cause issues for stormwater basin.

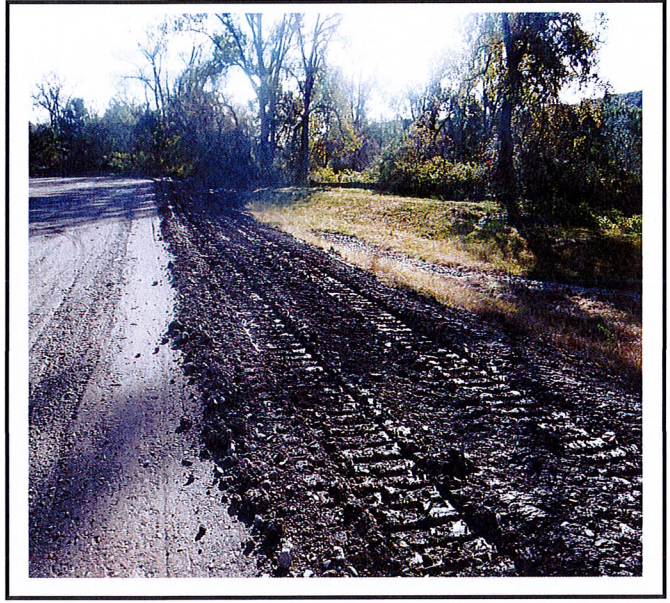
Finalized infiltration basin has been left exposed from recent grading activities. Any sediment getting into basin will be an issue.

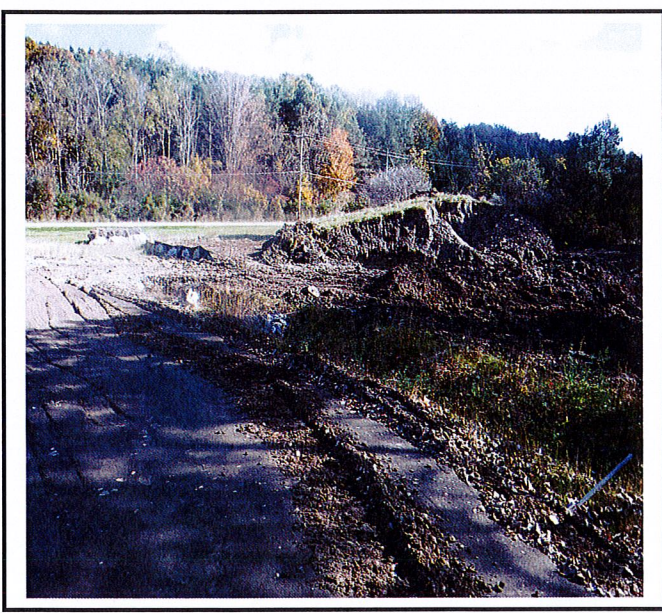
Topsoil area is going to need to be graded and stabilized prior to project closeout.
