Chemung County Stormwater
 Construction Inspection
 Erosion and Sediment Control

Project Name UHAUL	Date 6-1-17
Location State Route 14 Horseheads, NY	Permit #NYR11A438
Weather Conditions	Entry Time: 7:56
On-Site Representative Present: L. Crooker D. Reynolds	Exit Time: 8:25

PROJECT:	UHaul
	Town of Horseheads
	Municipal Inspection
	June 1, 2016
BY:	Jessica Verrigni, CPESC, CPSWQ

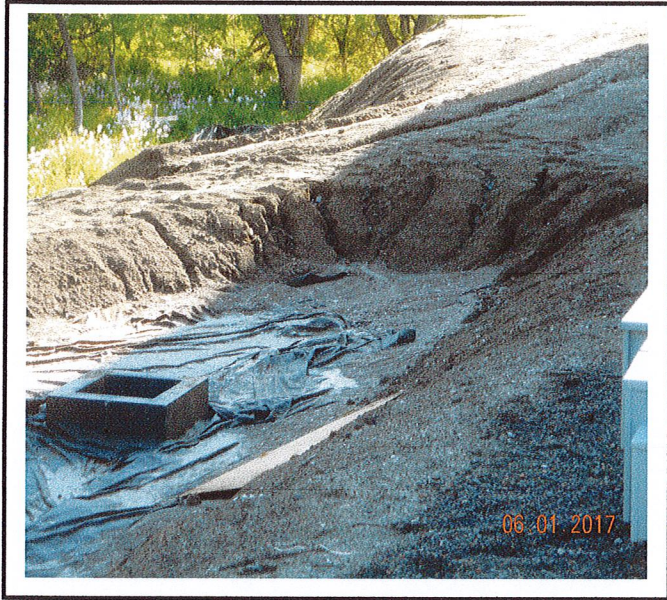
Bioretention area has not been completed. Bare soil has been left open and is now eroding. This silt will need to be removed and stabilization is required.

-Bioretention under construction has eroding side slopes. The eroded sediment is on top of fabric covering filtering media. Sediment must be removed, grading of side slopes repaired and complete bioretention & stabilize open soil.

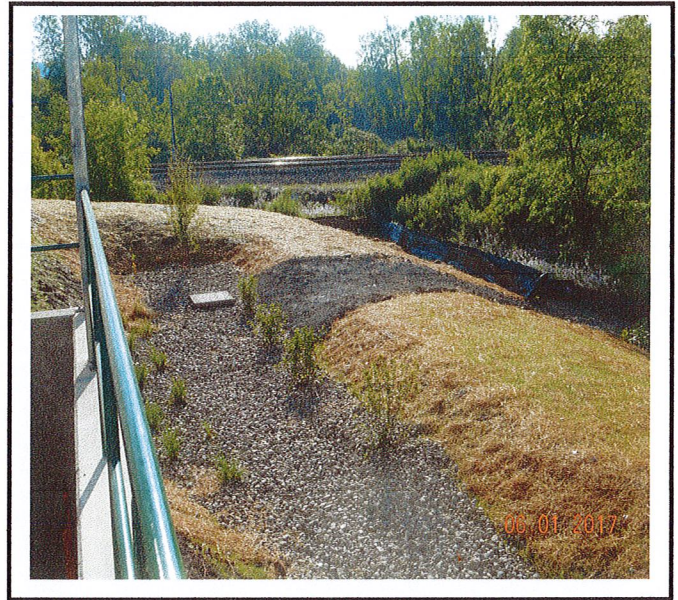
Finished bioretention #2 is complete.

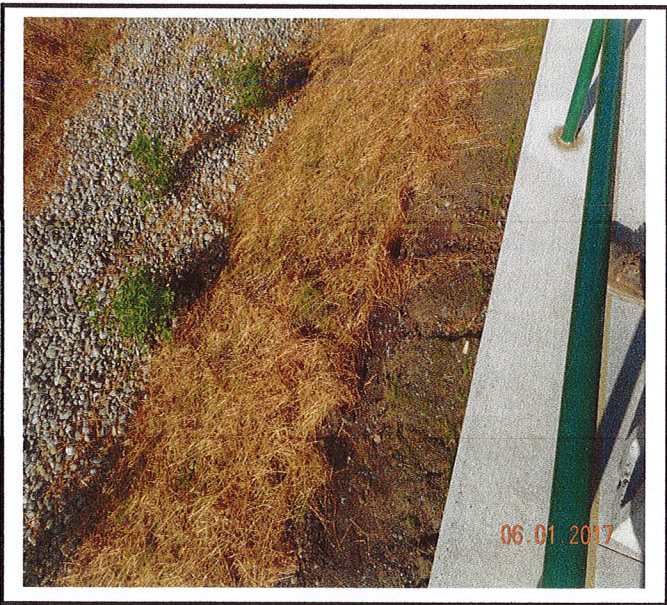
Side slopes of bioretention #2 require further erosion control efforts.

-Monitor erosion on slopes already stabilized. There are some mulched areas eroding from surface runoff. These need to be monitored to ensure erosion doesn't get out of control and become a problem.

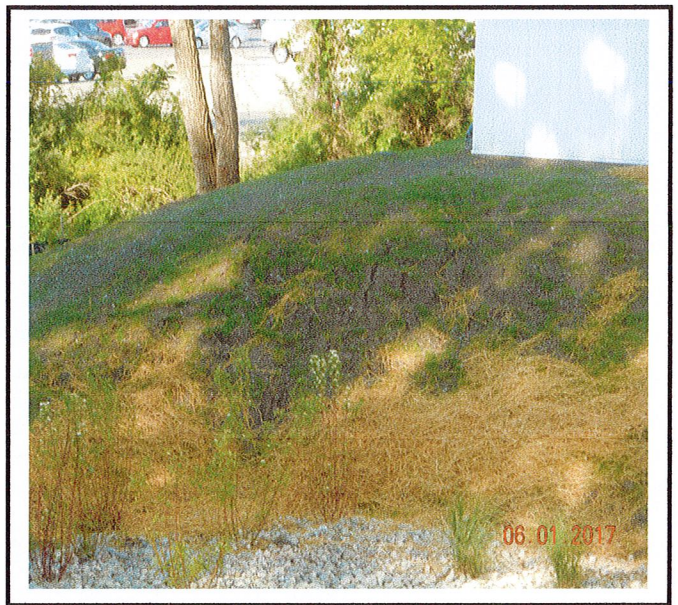
Further erosion control efforts are needed on these slopes.
